**CITY OF SAN MARCOS
ADA TRANSITION PLAN
SIGNALIZED INTERSECTION ASSESSMENT
AND COMPLIANCE REPORT**

Location ID: 000000082
 North-South Cross Street: IH 35 SBFR
 East-West Cross Street: SH 123

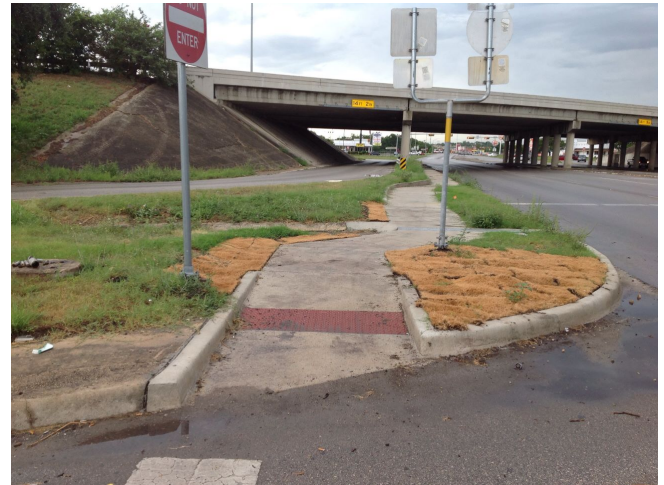
Signalized Intersection: YES
 Accessible Features: NO
 Pedestrian Features Accessible: NO

Ramp Elements	Curb ramp provided where an accessible route crosses a barrier:	YES
	Is the slope of the ramp 1:12 or less:	YES
	Transition from curb ramp slope to roadway free from abrupt changes, no greater than 1:20:	YES
	Ramp is at least 36" wide:	YES
	Ramp surface is stable, firm, and slip resistant:	YES
Flare	Flares (if present) are 1:10 or less measured along the curb line; or If landing at top of ramp is not provided flares are 1:12 or less:	N/A
Detectable Warning Surface	Curb ramp is located such that it does not project into roadway or parking aisles:	N/A
	Detectable warning is present:	YES
	DWS maintains correct geometric controls; 0.9" diameter domes, 0.2" in height, spaced at 2.35" and visually contracts adjacent ramp surface:	YES
Special Ramps	Ramp maintains defined edges parallel to direction of pedestrian travel; maintains 4'x4' turning pad contained in crosswalk; flared sides 24" segment on each side of ramp within crosswalk lines:	N/A

Ramp is located so they will not be obstructed by parked vehicles:	N/A
	Ramp wholly contained within the crosswalk lines:	N/A
	If island is present; Island maintains a cut through at street level or ramps on either side with landing between them:	N/A
