**CITY OF SAN MARCOS
ADA TRANSITION PLAN
SIGNALIZED INTERSECTION ASSESSMENT
AND COMPLIANCE REPORT**

Location ID: 000000109
 North-South Cross Street: HUGHSON DR
 East-West Cross Street: RANCH ROAD 12

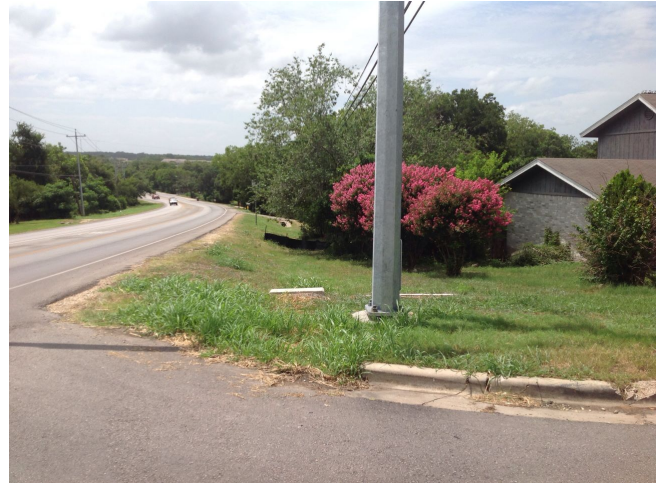
Signalized Intersection: YES
 Accessible Features: NO
 Pedestrian Features Accessible: NO

Ramp Elements	Curb ramp provided where an accessible route crosses a barrier:	NO
	Is the slope of the ramp 1:12 or less:	NO
	Transition from curb ramp slope to roadway free from abrupt changes, no greater than 1:20:	NO
	Ramp is at least 36" wide:	NO
	Ramp surface is stable, firm, and slip resistant:	NO
Flare	Flares (if present) are 1:10 or less measured along the curb line; or If landing at top of ramp is not provided flares are 1:12 or less:	NO
Detectable Warning Surface	Curb ramp is located such that it does not project into roadway or parking aisles:	N/A
	Detectable warning is present:	NO
	DWS maintains correct geometric controls; 0.9" diameter domes, 0.2" in height, spaced at 2.35" and visually contracts adjacent ramp surface:	NO
Special Ramps	Ramp maintains defined edges parallel to direction of pedestrian travel; maintains 4'x4' turning pad contained in crosswalk; flared sides 24" segment on each side of ramp within crosswalk lines:	N/A

Ramp is located so they will not be obstructed by parked vehicles:	N/A
	Ramp wholly contained within the crosswalk lines:	N/A
	If island is present; Island maintains a cut through at street level or ramps on either side with landing between them:	N/A
