CITY OF SAN MARCOS ADA TRANSITION PLAN SIGNALIZED INTERSECTION ASSESSMENT AND COMPLIANCE REPORT

Location ID: 000000110
 North-South Cross Street: HUGHSON DR
 East-West Cross Street: RANCH ROAD 12

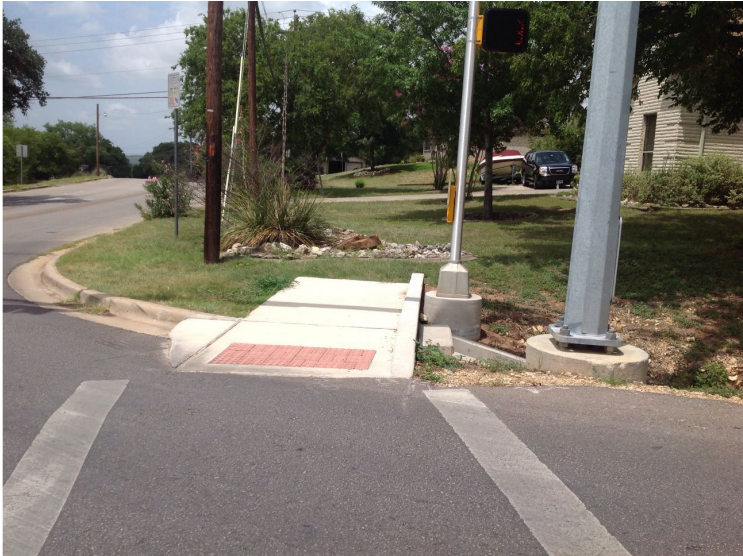
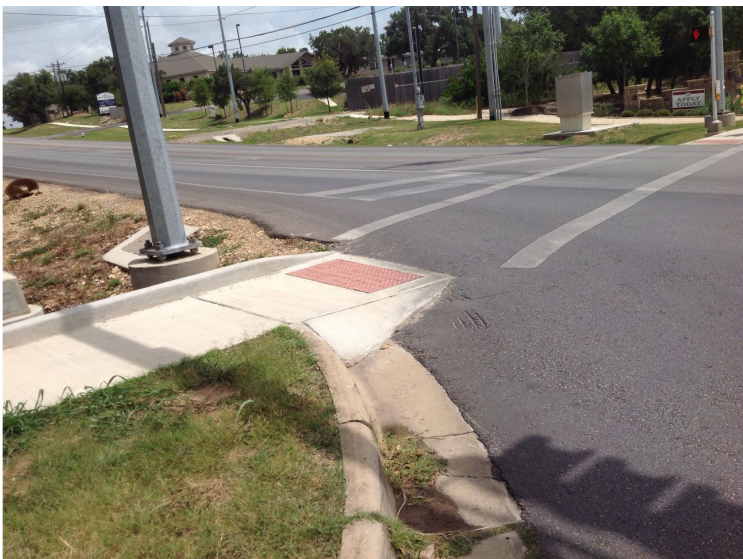
Location Photos

Ramp Elements	Curb ramp provided where an accessible route crosses a barrier:	YES
	Is the slope of the ramp 1:12 or less:	YES
	Transition from curb ramp slope to roadway free from abrupt changes, no greater than 1:20:	YES
	Ramp is at least 36" wide:	YES
	Ramp surface is stable, firm, and slip resistant:	YES
Flare	Flares (if present) are 1:10 or less measured along the curb line; or If landing at top of ramp is not provided flares are 1:12 or less:	NO
Detectable Warning Surface	Curb ramp is located such that it does not project into roadway or parking aisles:	NO
	Detectable warning is present:	YES
	DWS maintains correct geometric controls; 0.9" diameter domes, 0.2" in height, spaced at 2.35" and visually contrasts adjacent ramp surface:	YES
Special Ramps	Ramp maintains defined edges parallel to direction of pedestrian travel; maintains 4'x4' turning pad contained in crosswalk; flared sides 24" segment on each side of ramp within crosswalk lines:	N/A

Ramp is located so they will not be obstructed by parked vehicles:	N/A
	Ramp wholly contained within the crosswalk lines:	YES
	If island is present; Island maintains a cut through at street level or ramps on either side with landing between them:	N/A
