CITY OF SAN MARCOS ADA TRANSITION PLAN SIGNALIZED INTERSECTION ASSESSMENT AND COMPLIANCE REPORT

Location ID: 0000000112
 North-South Cross Street: SESSOM DR
 East-West Cross Street: COMANCHE ST

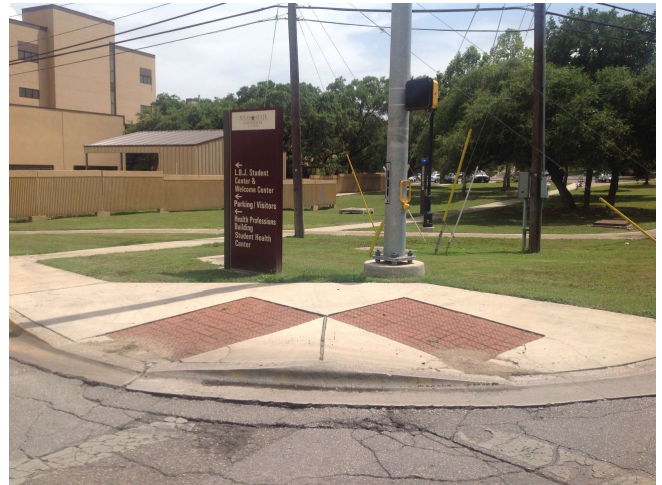
Signalized Intersection: YES
 Accessible Features: YES
 Pedestrian Features Accessible: YES

Ramp Elements	Curb ramp provided where an accessible route crosses a barrier:	YES
	Is the slope of the ramp 1:12 or less:	NO
	Transition from curb ramp slope to roadway free from abrupt changes, no greater than 1:20:	NO
	Ramp is at least 36" wide:	YES
	Ramp surface is stable, firm, and slip resistant:	
Flare	Flares (if present) are 1:10 or less measured along the curb line; or If landing at top of ramp is not provided flares are 1:12 or less:	YES
Detectable Warning Surface	Curb ramp is located such that it does not project into roadway or parking aisles:	N/A
	Detectable warning is present:	YES
	DWS maintains correct geometric controls; 0.9" diameter domes, 0.2" in height, spaced at 2.35" and visually contrasts adjacent ramp surface:	YES
Special Ramps	Ramp maintains defined edges parallel to direction of pedestrian travel; maintains 4'x4' turning pad contained in crosswalk; flared sides 24" segment on each side of ramp within crosswalk lines:	N/A

Ramp is located so they will not be obstructed by parked vehicles:	N/A
	Ramp wholly contained within the crosswalk lines:	YES
	If island is present; Island maintains a cut through at street level or ramps on either side with landing between them:	N/A
