**CITY OF SAN MARCOS
ADA TRANSITION PLAN
SIGNALIZED INTERSECTION ASSESSMENT
AND COMPLIANCE REPORT**

Location ID: 0000000124
 North-South Cross Street: UNIVERSITY DR
 East-West Cross Street: LBJ ST

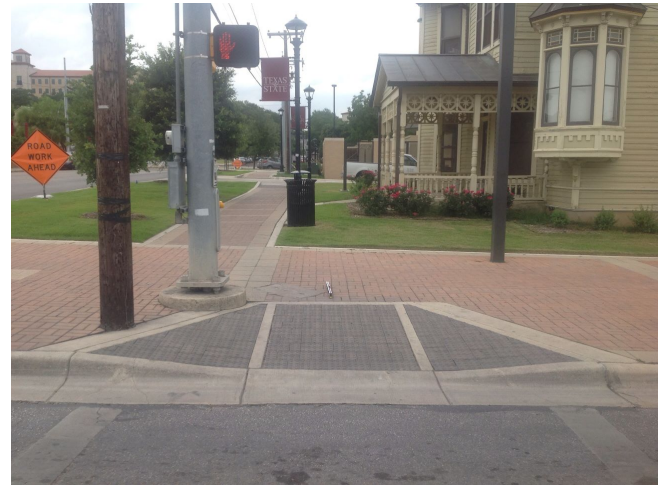
Ramp Elements	Curb ramp provided where an accessible route crosses a barrier:	YES
	Is the slope of the ramp 1:12 or less:	YES
	Transition from curb ramp slope to roadway free from abrupt changes, no greater than 1:20:	YES
	Ramp is at least 36" wide:	YES
	Ramp surface is stable, firm, and slip resistant:	YES
Flare	Flares (if present) are 1:10 or less measured along the curb line; or If landing at top of ramp is not provided flares are 1:12 or less:	NO
Detectable Warning Surface	Curb ramp is located such that it does not project into roadway or parking aisles:	N/A
	Detectable warning is present:	YES
	DWS maintains correct geometric controls; 0.9" diameter domes, 0.2" in height, spaced at 2.35" and visually contrasts adjacent ramp surface:	NO
Special Ramps	Ramp maintains defined edges parallel to direction of pedestrian travel; maintains 4'x4' turning pad contained in crosswalk; flared sides 24" segment on each side of ramp within crosswalk lines:	N/A

Ramp is located so they will not be obstructed by parked vehicles:	N/A
	Ramp wholly contained within the crosswalk lines:	YES
	If island is present; Island maintains a cut through at street level or ramps on either side with landing between them:	N/A
