CITY OF SAN MARCOS ADA TRANSITION PLAN SIGNALIZED INTERSECTION ASSESSMENT AND COMPLIANCE REPORT

Location ID: 0000000126
 North-South Cross Street: PAT GARRISON ST
 East-West Cross Street: GUADALUPE ST

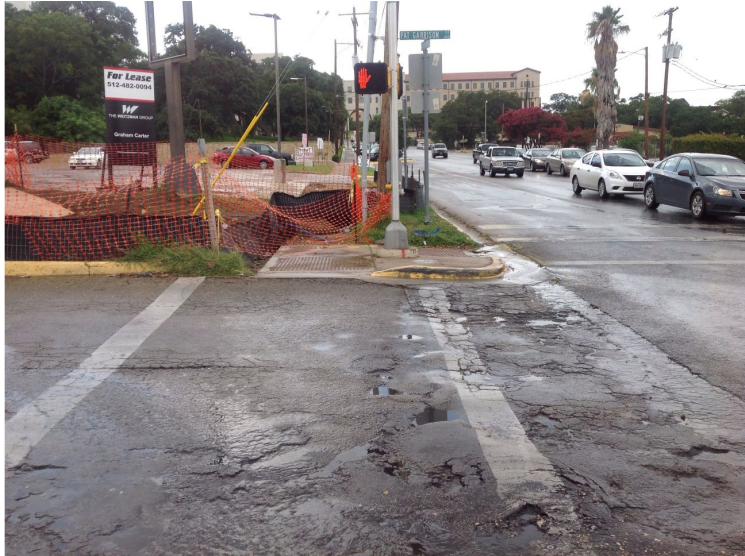
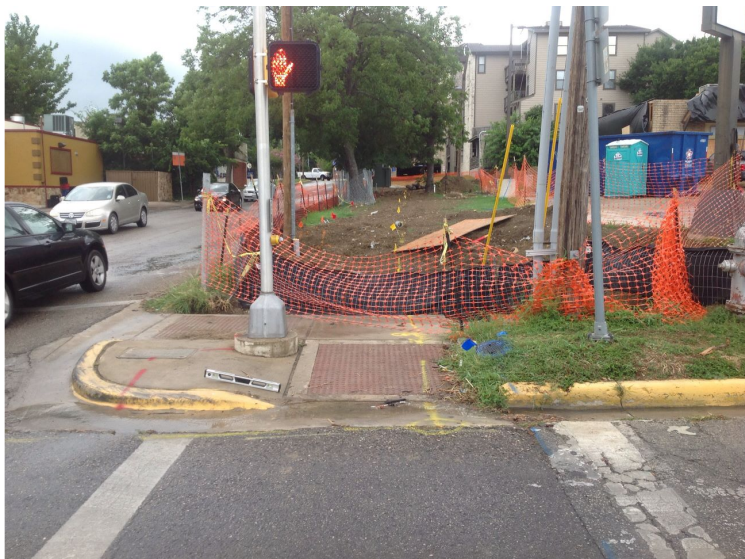
Location Photos

Ramp Elements	Curb ramp provided where an accessible route crosses a barrier:	YES
	Is the slope of the ramp 1:12 or less:	YES
	Transition from curb ramp slope to roadway free from abrupt changes, no greater than 1:20:	NO
	Ramp is at least 36" wide:	NO
	Ramp surface is stable, firm, and slip resistant:	YES
Flare	Flares (if present) are 1:10 or less measured along the curb line; or If landing at top of ramp is not provided flares are 1:12 or less:	NO
Detectable Warning Surface	Curb ramp is located such that it does not project into roadway or parking aisles:	N/A
	Detectable warning is present:	YES
	DWS maintains correct geometric controls; 0.9" diameter domes, 0.2" in height, spaced at 2.35" and visually contracts adjacent ramp surface:	YES
Special Ramps	Ramp maintains defined edges parallel to direction of pedestrian travel; maintains 4'x4' turning pad contained in crosswalk; flared sides 24" segment on each side of ramp within crosswalk lines:	N/A

Ramp is located so they will not be obstructed by parked vehicles:	N/A
	Ramp wholly contained within the crosswalk lines:	YES
	If island is present; Island maintains a cut through at street level or ramps on either side with landing between them:	N/A
