CITY OF SAN MARCOS ADA TRANSITION PLAN SIGNALIZED INTERSECTION ASSESSMENT AND COMPLIANCE REPORT

Location ID: 0000000127
 North-South Cross Street: PAT GARRISON ST
 East-West Cross Street: GUADALUPE ST

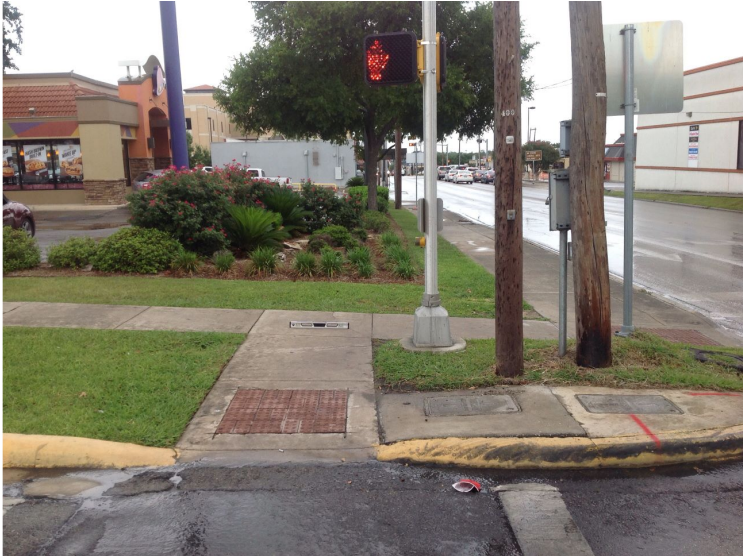
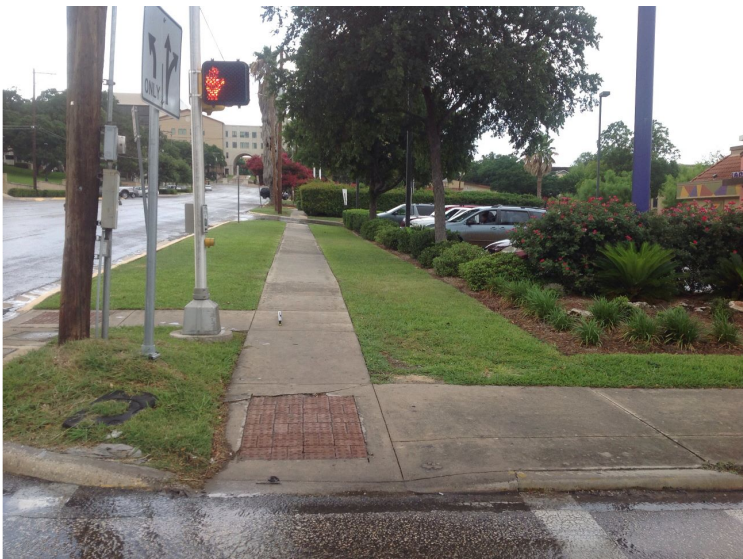
Location Photos

Ramp Elements	Curb ramp provided where an accessible route crosses a barrier:	YES
	Is the slope of the ramp 1:12 or less:	YES
	Transition from curb ramp slope to roadway free from abrupt changes, no greater than 1:20:	NO
	Ramp is at least 36" wide:	NO
	Ramp surface is stable, firm, and slip resistant:	YES
Flare	Flares (if present) are 1:10 or less measured along the curb line; or If landing at top of ramp is not provided flares are 1:12 or less:	NO
Detectable Warning Surface	Curb ramp is located such that it does not project into roadway or parking aisles:	N/A
	Detectable warning is present:	NO
	DWS maintains correct geometric controls; 0.9" diameter domes, 0.2" in height, spaced at 2.35" and visually contracts adjacent ramp surface:	YES
Special Ramps	Ramp maintains defined edges parallel to direction of pedestrian travel; maintains 4'x4' turning pad contained in crosswalk; flared sides 24" segment on each side of ramp within crosswalk lines:	N/A
