**CITY OF SAN MARCOS  
ADA TRANSITION PLAN  
SIGNALIZED INTERSECTION ASSESSMENT  
AND COMPLIANCE REPORT**

Location ID: 0000000144  
 North-South Cross Street: UNIVERSITY DR  
 East-West Cross Street: CM ALLEN PKWY

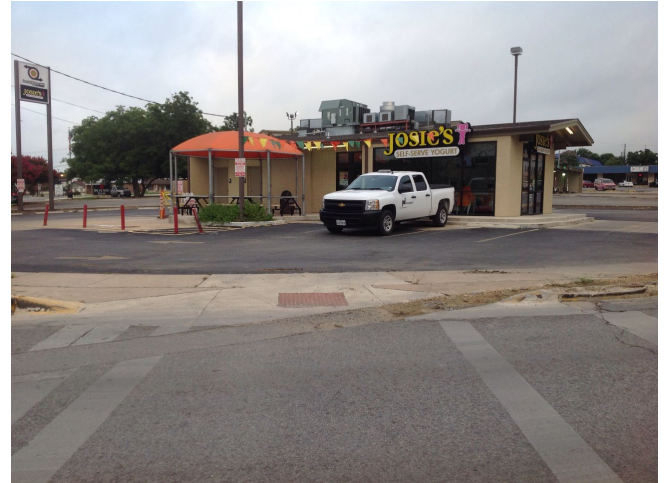
<b>Ramp Elements</b>	Curb ramp provided where an accessible route crosses a barrier:	YES
	Is the slope of the ramp 1:12 or less:	YES
	Transition from curb ramp slope to roadway free from abrupt changes, no greater than 1:20:	NO
	Ramp is at least 36" wide:	YES
	Ramp surface is stable, firm, and slip resistant:	YES
<b>Flare</b>	Flares (if present) are 1:10 or less measured along the curb line; or If landing at top of ramp is not provided flares are 1:12 or less:	YES
<b>Detectable Warning Surface</b>	Curb ramp is located such that it does not project into roadway or parking aisles:	N/A
	Detectable warning is present:	NO
	DWS maintains correct geometric controls; 0.9" diameter domes, 0.2" in height, spaced at 2.35" and visually contracts adjacent ramp surface:	YES
<b>Special Ramps</b>	Ramp maintains defined edges parallel to direction of pedestrian travel; maintains 4'x4' turning pad contained in crosswalk; flared sides 24" segment on each side of ramp within crosswalk lines:	N/A

Ramp is located so they will not be obstructed by parked vehicles:	N/A
	Ramp wholly contained within the crosswalk lines:	YES
	If island is present; Island maintains a cut through at street level or ramps on either side with landing between them:	YES
