CITY OF SAN MARCOS ADA TRANSITION PLAN SIGNALIZED INTERSECTION ASSESSMENT AND COMPLIANCE REPORT

Location ID: 0000000146
 North-South Cross Street: UNIVERSITY DR
 East-West Cross Street: CM ALLEN PKWY

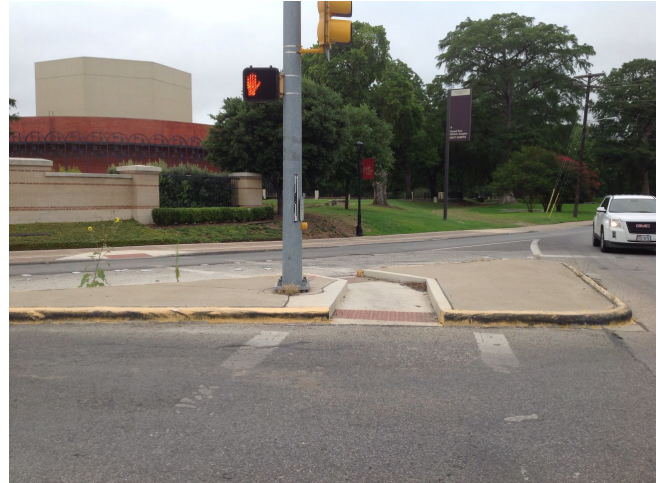
Signalized Intersection: YES
 Accessible Features: YES
 Pedestrian Features Accessible: YES

Ramp Elements	Curb ramp provided where an accessible route crosses a barrier:	YES
	Is the slope of the ramp 1:12 or less:	YES
	Transition from curb ramp slope to roadway free from abrupt changes, no greater than 1:20:	YES
	Ramp is at least 36" wide:	YES
	Ramp surface is stable, firm, and slip resistant:	YES
Flare	Flares (if present) are 1:10 or less measured along the curb line; or If landing at top of ramp is not provided flares are 1:12 or less:	N/A
Detectable Warning Surface	Curb ramp is located such that it does not project into roadway or parking aisles:	N/A
	Detectable warning is present:	YES
	DWS maintains correct geometric controls; 0.9" diameter domes, 0.2" in height, spaced at 2.35" and visually contracts adjacent ramp surface:	YES
Special Ramps	Ramp maintains defined edges parallel to direction of pedestrian travel; maintains 4'x4' turning pad contained in crosswalk; flared sides 24" segment on each side of ramp within crosswalk lines:	N/A

Ramp is located so they will not be obstructed by parked vehicles:	N/A
	Ramp wholly contained within the crosswalk lines:	YES
	If island is present; Island maintains a cut through at street level or ramps on either side with landing between them:	YES
