**CITY OF SAN MARCOS
ADA TRANSITION PLAN
SIGNALIZED INTERSECTION ASSESSMENT
AND COMPLIANCE REPORT**

Location ID: 0000000151
 North-South Cross Street: SESSOM DR
 East-West Cross Street: PEQUES ST

Location ID: 0000000151

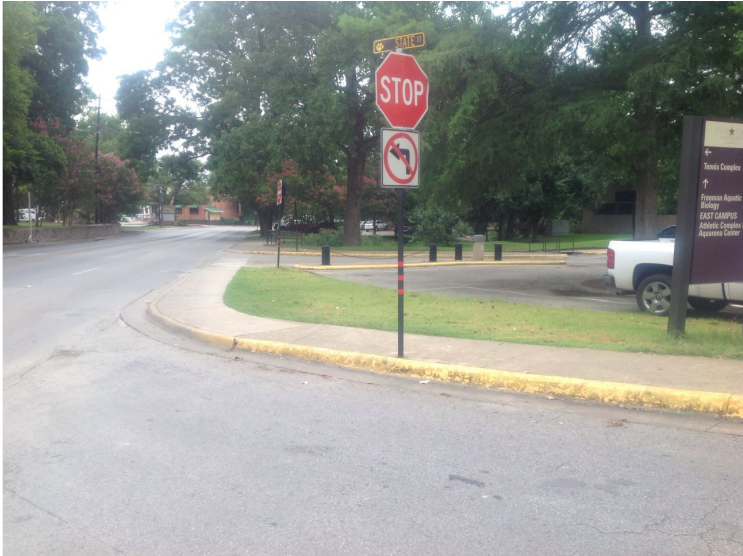
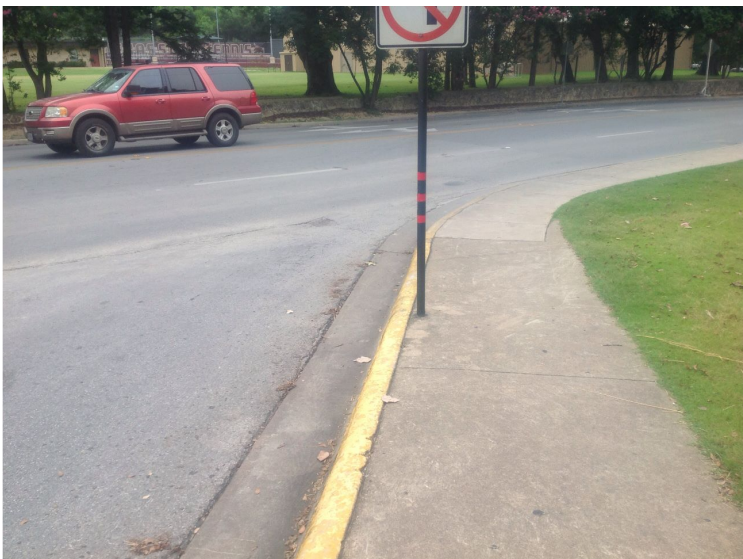
Location Photos

Ramp Elements	Curb ramp provided where an accessible route crosses a barrier:	NO
	Is the slope of the ramp 1:12 or less:	NO
	Transition from curb ramp slope to roadway free from abrupt changes, no greater than 1:20:	NO
	Ramp is at least 36" wide:	NO
	Ramp surface is stable, firm, and slip resistant:	NO
Flare	Flares (if present) are 1:10 or less measured along the curb line; or If landing at top of ramp is not provided flares are 1:12 or less:	NO
Detectable Warning Surface	Curb ramp is located such that it does not project into roadway or parking aisles:	N/A
	Detectable warning is present:	NO
	DWS maintains correct geometric controls; 0.9" diameter domes, 0.2" in height, spaced at 2.35" and visually contrasts adjacent ramp surface:	NO
Special Ramps	Ramp maintains defined edges parallel to direction of pedestrian travel; maintains 4'x4' turning pad contained in crosswalk; flared sides 24" segment on each side of ramp within crosswalk lines:	N/A
