CITY OF SAN MARCOS ADA TRANSITION PLAN SIGNALIZED INTERSECTION ASSESSMENT AND COMPLIANCE REPORT

Location ID: 0000000153
 North-South Cross Street: SESSOM DR
 East-West Cross Street: LBJ DR

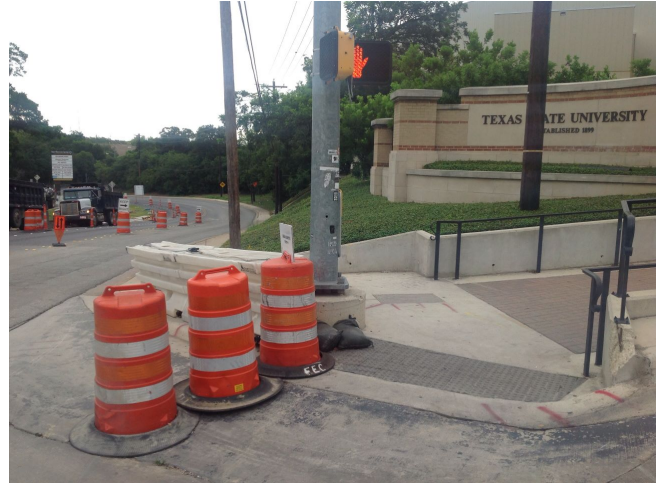
Ramp Elements	Curb ramp provided where an accessible route crosses a barrier:	YES
	Is the slope of the ramp 1:12 or less:	YES
	Transition from curb ramp slope to roadway free from abrupt changes, no greater than 1:20:	NO
	Ramp is at least 36" wide:	YES
	Ramp surface is stable, firm, and slip resistant:	YES
Flare	Flares (if present) are 1:10 or less measured along the curb line; or If landing at top of ramp is not provided flares are 1:12 or less:	N/A
Detectable Warning Surface	Curb ramp is located such that it does not project into roadway or parking aisles:	N/A
	Detectable warning is present:	YES
	DWS maintains correct geometric controls; 0.9" diameter domes, 0.2" in height, spaced at 2.35" and visually contracts adjacent ramp surface:	YES
Special Ramps	Ramp maintains defined edges parallel to direction of pedestrian travel; maintains 4'x4' turning pad contained in crosswalk; flared sides 24" segment on each side of ramp within crosswalk lines:	N/A

Ramp is located so they will not be obstructed by parked vehicles:	N/A
	Ramp wholly contained within the crosswalk lines:	YES
	If island is present; Island maintains a cut through at street level or ramps on either side with landing between them:	N/A
