**CITY OF SAN MARCOS
ADA TRANSITION PLAN
SIGNALIZED INTERSECTION ASSESSMENT
AND COMPLIANCE REPORT**

Location ID: 0000000155
 North-South Cross Street: AQUARINA SPRINGS DR
 East-West Cross Street: CHARLES AUSTIN DR

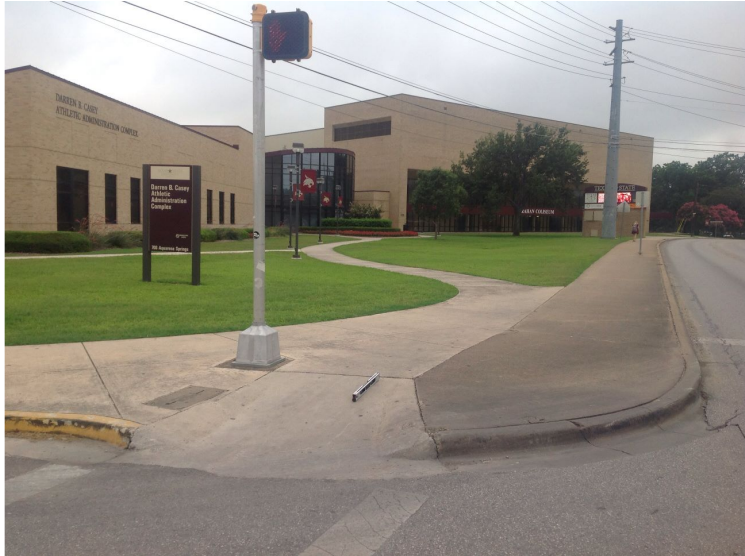
Location Photos

Ramp Elements	Curb ramp provided where an accessible route crosses a barrier:	YES
	Is the slope of the ramp 1:12 or less:	NO
	Transition from curb ramp slope to roadway free from abrupt changes, no greater than 1:20:	YES
	Ramp is at least 36" wide:	YES
	Ramp surface is stable, firm, and slip resistant:	YES
Flare	Flares (if present) are 1:10 or less measured along the curb line; or If landing at top of ramp is not provided flares are 1:12 or less:	NO
Detectable Warning Surface	Curb ramp is located such that it does not project into roadway or parking aisles:	N/A
	Detectable warning is present:	NO
	DWS maintains correct geometric controls; 0.9" diameter domes, 0.2" in height, spaced at 2.35" and visually contrasts adjacent ramp surface:	NO
Special Ramps	Ramp maintains defined edges parallel to direction of pedestrian travel; maintains 4'x4' turning pad contained in crosswalk; flared sides 24" segment on each side of ramp within crosswalk lines:	N/A

Ramp is located so they will not be obstructed by parked vehicles:	N/A
	Ramp wholly contained within the crosswalk lines:	YES
	If island is present; Island maintains a cut through at street level or ramps on either side with landing between them:	N/A
