CITY OF SAN MARCOS ADA TRANSITION PLAN SIGNALIZED INTERSECTION ASSESSMENT AND COMPLIANCE REPORT

Location ID: 000000161
 North-South Cross Street: THORPE LN
 East-West Cross Street: ROBBIE LN

Location ID: 0000000161

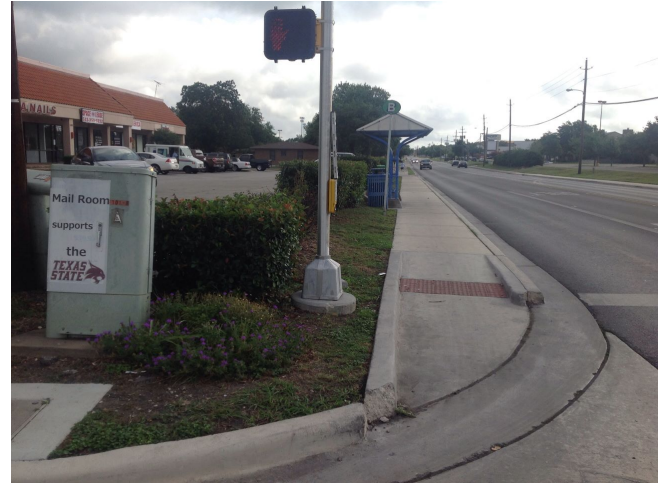
Signalized Intersection: YES
 Accessible Features: YES
 Pedestrian Features Accessible: YES

Ramp Elements	Curb ramp provided where an accessible route crosses a barrier:	YES
	Is the slope of the ramp 1:12 or less:	YES
	Transition from curb ramp slope to roadway free from abrupt changes, no greater than 1:20:	YES
	Ramp is at least 36" wide:	YES
	Ramp surface is stable, firm, and slip resistant:	YES
Flare	Flares (if present) are 1:10 or less measured along the curb line; or If landing at top of ramp is not provided flares are 1:12 or less:	N/A
Detectable Warning Surface	Curb ramp is located such that it does not project into roadway or parking aisles:	N/A
	Detectable warning is present:	YES
	DWS maintains correct geometric controls; 0.9" diameter domes, 0.2" in height, spaced at 2.35" and visually contracts adjacent ramp surface:	YES
Special Ramps	Ramp maintains defined edges parallel to direction of pedestrian travel; maintains 4'x4' turning pad contained in crosswalk; flared sides 24" segment on each side of ramp within crosswalk lines:	N/A

Ramp is located so they will not be obstructed by parked vehicles:	N/A
	Ramp wholly contained within the crosswalk lines:	NO
	If island is present; Island maintains a cut through at street level or ramps on either side with landing between them:	N/A
