CITY OF SAN MARCOS ADA TRANSITION PLAN SIGNALIZED INTERSECTION ASSESSMENT AND COMPLIANCE REPORT

Location ID: 0000000170
 North-South Cross Street: IH 35 SBFR
 East-West Cross Street: AQUARENA SPRINGS DR

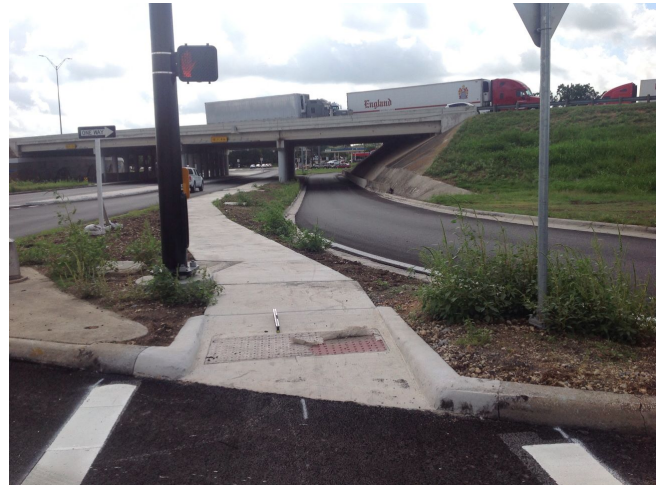
Ramp Elements	Curb ramp provided where an accessible route crosses a barrier:	YES
	Is the slope of the ramp 1:12 or less:	YES
	Transition from curb ramp slope to roadway free from abrupt changes, no greater than 1:20:	YES
	Ramp is at least 36" wide:	YES
	Ramp surface is stable, firm, and slip resistant:	YES
Flare	Flares (if present) are 1:10 or less measured along the curb line; or If landing at top of ramp is not provided flares are 1:12 or less:	N/A
Detectable Warning Surface	Curb ramp is located such that it does not project into roadway or parking aisles:	N/A
	Detectable warning is present:	YES
	DWS maintains correct geometric controls; 0.9" diameter domes, 0.2" in height, spaced at 2.35" and visually contracts adjacent ramp surface:	YES
Special Ramps	Ramp maintains defined edges parallel to direction of pedestrian travel; maintains 4'x4' turning pad contained in crosswalk; flared sides 24" segment on each side of ramp within crosswalk lines:	N/A

Ramp is located so they will not be obstructed by parked vehicles:	N/A
	Ramp wholly contained within the crosswalk lines:	YES
	If island is present; Island maintains a cut through at street level or ramps on either side with landing between them:	YES
