CITY OF SAN MARCOS ADA TRANSITION PLAN SIGNALIZED INTERSECTION ASSESSMENT AND COMPLIANCE REPORT

Location ID: 0000000191
 North-South Cross Street: CLAREWOOD DR
 East-West Cross Street: TX HWY 80

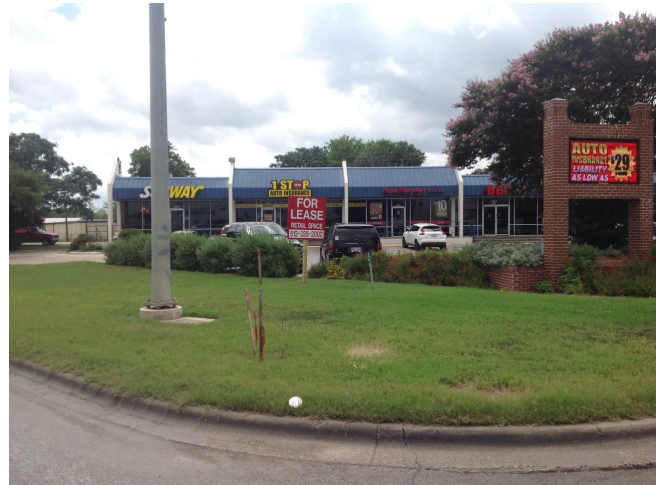
Signalized Intersection: YES
 Accessible Features: NO
 Pedestrian Features Accessible: NO

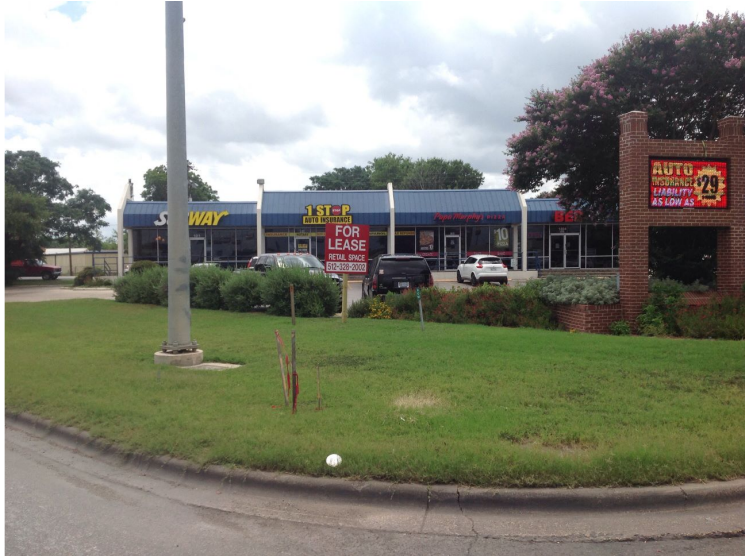
Location Photos

Ramp Elements	Curb ramp provided where an accessible route crosses a barrier:	NO
	Is the slope of the ramp 1:12 or less:	NO
	Transition from curb ramp slope to roadway free from abrupt changes, no greater than 1:20:	NO
	Ramp is at least 36" wide:	NO
	Ramp surface is stable, firm, and slip resistant:	NO
Flare	Flares (if present) are 1:10 or less measured along the curb line; or If landing at top of ramp is not provided flares are 1:12 or less:	NO
Detectable Warning Surface	Curb ramp is located such that it does not project into roadway or parking aisles:	N/A
	Detectable warning is present:	NO
	DWS maintains correct geometric controls; 0.9" diameter domes, 0.2" in height, spaced at 2.35" and visually contracts adjacent ramp surface:	NO
Special Ramps	Ramp maintains defined edges parallel to direction of pedestrian travel; maintains 4'x4' turning pad contained in crosswalk; flared sides 24" segment on each side of ramp within crosswalk lines:	N/A
