**CITY OF SAN MARCOS
ADA TRANSITION PLAN
SIGNALIZED INTERSECTION ASSESSMENT
AND COMPLIANCE REPORT**

Location ID: 000000210
 North-South Cross Street: SH 123
 East-West Cross Street: HAYS ST

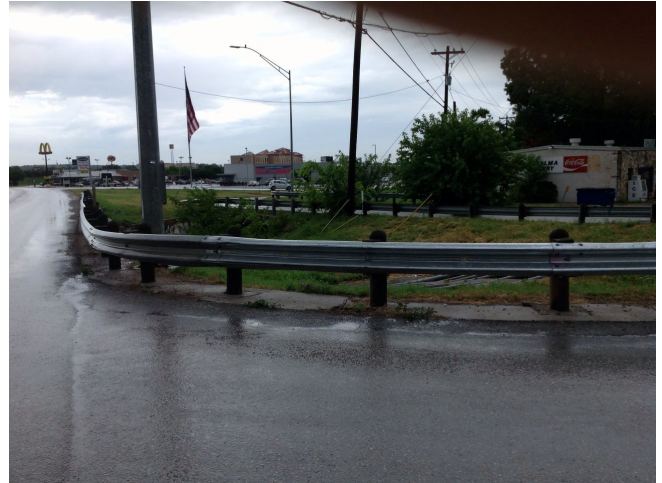
Signalized Intersection: YES
 Accessible Features: NO
 Pedestrian Features Accessible: NO

Ramp Elements	Curb ramp provided where an accessible route crosses a barrier:	NO
	Is the slope of the ramp 1:12 or less:	NO
	Transition from curb ramp slope to roadway free from abrupt changes, no greater than 1:20:	NO
	Ramp is at least 36" wide:	NO
	Ramp surface is stable, firm, and slip resistant:	NO
Flare	Flares (if present) are 1:10 or less measured along the curb line; or If landing at top of ramp is not provided flares are 1:12 or less:	NO
Detectable Warning Surface	Curb ramp is located such that it does not project into roadway or parking aisles:	N/A
	Detectable warning is present:	NO
	DWS maintains correct geometric controls; 0.9" diameter domes, 0.2" in height, spaced at 2.35" and visually contracts adjacent ramp surface:	NO
Special Ramps	Ramp maintains defined edges parallel to direction of pedestrian travel; maintains 4'x4' turning pad contained in crosswalk; flared sides 24" segment on each side of ramp within crosswalk lines:	N/A

Ramp is located so they will not be obstructed by parked vehicles:	N/A
	Ramp wholly contained within the crosswalk lines:	N/A
	If island is present; Island maintains a cut through at street level or ramps on either side with landing between them:	N/A
