CITY OF SAN MARCOS ADA TRANSITION PLAN SIGNALIZED INTERSECTION ASSESSMENT AND COMPLIANCE REPORT

Location ID: 0000000217
 North-South Cross Street: GUADALUPE ST
 East-West Cross Street: ROOSEVELT ST

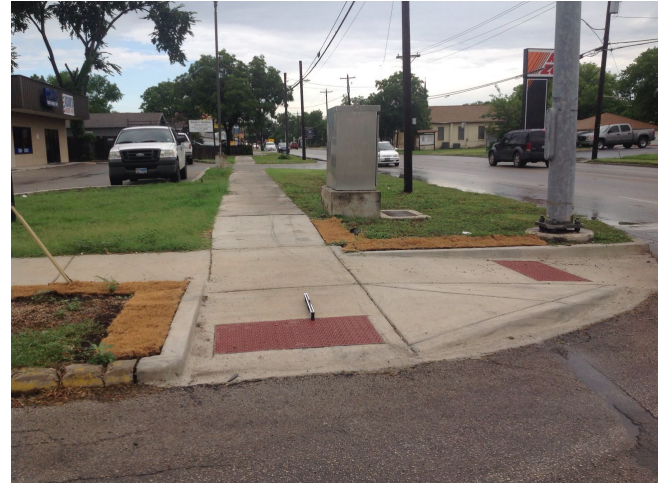
Signalized Intersection: YES
 Accessible Features: NO
 Pedestrian Features Accessible: NO

Ramp Elements	Curb ramp provided where an accessible route crosses a barrier:	YES
	Is the slope of the ramp 1:12 or less:	YES
	Transition from curb ramp slope to roadway free from abrupt changes, no greater than 1:20:	YES
	Ramp is at least 36" wide:	YES
	Ramp surface is stable, firm, and slip resistant:	YES
Flare	Flares (if present) are 1:10 or less measured along the curb line; or If landing at top of ramp is not provided flares are 1:12 or less:	YES
Detectable Warning Surface	Curb ramp is located such that it does not project into roadway or parking aisles:	N/A
	Detectable warning is present:	YES
	DWS maintains correct geometric controls; 0.9" diameter domes, 0.2" in height, spaced at 2.35" and visually contrasts adjacent ramp surface:	YES
Special Ramps	Ramp maintains defined edges parallel to direction of pedestrian travel; maintains 4'x4' turning pad contained in crosswalk; flared sides 24" segment on each side of ramp within crosswalk lines:	N/A

Ramp is located so they will not be obstructed by parked vehicles:	N/A
	Ramp wholly contained within the crosswalk lines:	N/A
	If island is present; Island maintains a cut through at street level or ramps on either side with landing between them:	N/A
