**CITY OF SAN MARCOS
ADA TRANSITION PLAN
SIGNALIZED INTERSECTION ASSESSMENT
AND COMPLIANCE REPORT**

Location ID: 000000227
 North-South Cross Street: CRADDOCK AVE
 East-West Cross Street: WONDERWORLD DR

Location ID: 0000000227

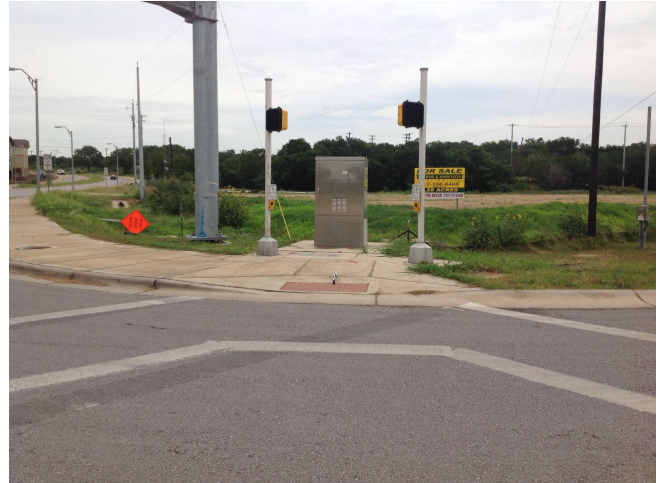
Signalized Intersection: YES
 Accessible Features: YES
 Pedestrian Features Accessible: YES

Ramp Elements	Curb ramp provided where an accessible route crosses a barrier:	YES
	Is the slope of the ramp 1:12 or less:	YES
	Transition from curb ramp slope to roadway free from abrupt changes, no greater than 1:20:	YES
	Ramp is at least 36" wide:	YES
	Ramp surface is stable, firm, and slip resistant:	YES
Flare	Flares (if present) are 1:10 or less measured along the curb line; or If landing at top of ramp is not provided flares are 1:12 or less:	YES
Detectable Warning Surface	Curb ramp is located such that it does not project into roadway or parking aisles:	N/A
	Detectable warning is present:	YES
	DWS maintains correct geometric controls; 0.9" diameter domes, 0.2" in height, spaced at 2.35" and visually contrasts adjacent ramp surface:	YES
Special Ramps	Ramp maintains defined edges parallel to direction of pedestrian travel; maintains 4'x4' turning pad contained in crosswalk; flared sides 24" segment on each side of ramp within crosswalk lines:	NO

Ramp is located so they will not be obstructed by parked vehicles:	N/A
	Ramp wholly contained within the crosswalk lines:	YES
	If island is present; Island maintains a cut through at street level or ramps on either side with landing between them:	N/A
