**CITY OF SAN MARCOS
ADA TRANSITION PLAN
SIGNALIZED INTERSECTION ASSESSMENT
AND COMPLIANCE REPORT**

Location ID: 0000000229
 North-South Cross Street: HUNTER RD
 East-West Cross Street: WONDERWORLD DR

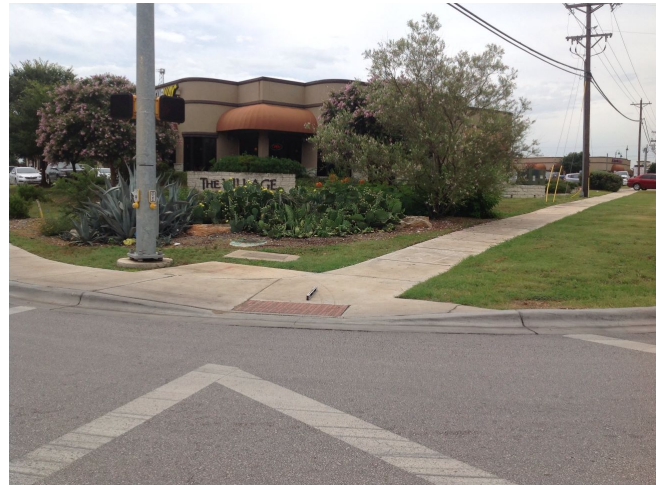
Signalized Intersection: YES
 Accessible Features: YES
 Pedestrian Features Accessible: YES

Ramp Elements	Curb ramp provided where an accessible route crosses a barrier:	YES
	Is the slope of the ramp 1:12 or less:	NO
	Transition from curb ramp slope to roadway free from abrupt changes, no greater than 1:20:	YES
	Ramp is at least 36" wide:	YES
	Ramp surface is stable, firm, and slip resistant:	
Flare	Flares (if present) are 1:10 or less measured along the curb line; or If landing at top of ramp is not provided flares are 1:12 or less:	YES
Detectable Warning Surface	Curb ramp is located such that it does not project into roadway or parking aisles:	N/A
	Detectable warning is present:	YES
	DWS maintains correct geometric controls; 0.9" diameter domes, 0.2" in height, spaced at 2.35" and visually contracts adjacent ramp surface:	YES
Special Ramps	Ramp maintains defined edges parallel to direction of pedestrian travel; maintains 4'x4' turning pad contained in crosswalk; flared sides 24" segment on each side of ramp within crosswalk lines:	YES

Ramp is located so they will not be obstructed by parked vehicles:	N/A
	Ramp wholly contained within the crosswalk lines:	YES
	If island is present; Island maintains a cut through at street level or ramps on either side with landing between them:	N/A
