**CITY OF SAN MARCOS
ADA TRANSITION PLAN
SIGNALIZED INTERSECTION ASSESSMENT
AND COMPLIANCE REPORT**

Location ID: 0000000231
 North-South Cross Street: S STAGECOACH TR
 East-West Cross Street: WONDERWORLD DR

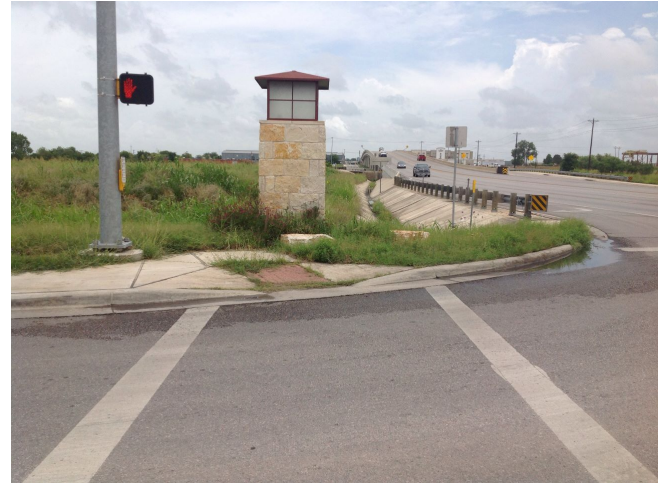
Ramp Elements	Curb ramp provided where an accessible route crosses a barrier:	YES
	Is the slope of the ramp 1:12 or less:	NO
	Transition from curb ramp slope to roadway free from abrupt changes, no greater than 1:20:	YES
	Ramp is at least 36" wide:	YES
	Ramp surface is stable, firm, and slip resistant:	YES
Flare	Flares (if present) are 1:10 or less measured along the curb line; or If landing at top of ramp is not provided flares are 1:12 or less:	YES
Detectable Warning Surface	Curb ramp is located such that it does not project into roadway or parking aisles:	N/A
	Detectable warning is present:	YES
	DWS maintains correct geometric controls; 0.9" diameter domes, 0.2" in height, spaced at 2.35" and visually contracts adjacent ramp surface:	YES
Special Ramps	Ramp maintains defined edges parallel to direction of pedestrian travel; maintains 4'x4' turning pad contained in crosswalk; flared sides 24" segment on each side of ramp within crosswalk lines:	N/A

Ramp is located so they will not be obstructed by parked vehicles:	N/A
	Ramp wholly contained within the crosswalk lines:	YES
	If island is present; Island maintains a cut through at street level or ramps on either side with landing between them:	N/A
