**CITY OF SAN MARCOS
ADA TRANSITION PLAN
SIGNALIZED INTERSECTION ASSESSMENT
AND COMPLIANCE REPORT**

Location ID: 0000000235
 North-South Cross Street: HUNTER RD
 East-West Cross Street: FOXTAIL RUN

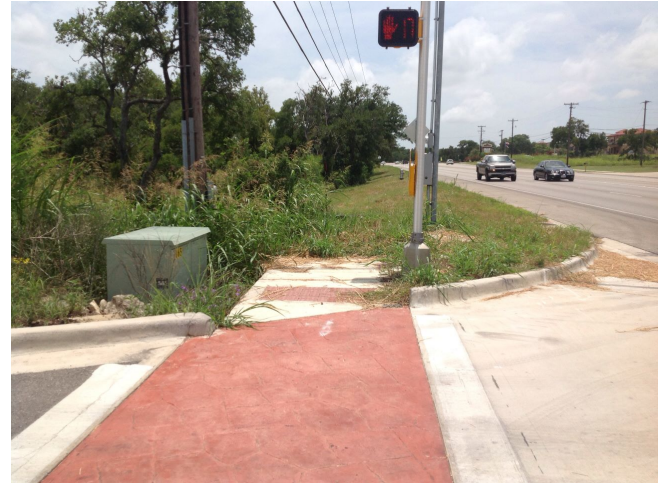
Signalized Intersection: YES
 Accessible Features: YES
 Pedestrian Features Accessible: YES

Ramp Elements	Curb ramp provided where an accessible route crosses a barrier:	YES
	Is the slope of the ramp 1:12 or less:	YES
	Transition from curb ramp slope to roadway free from abrupt changes, no greater than 1:20:	YES
	Ramp is at least 36" wide:	YES
	Ramp surface is stable, firm, and slip resistant:	YES
Flare	Flares (if present) are 1:10 or less measured along the curb line; or If landing at top of ramp is not provided flares are 1:12 or less:	NO
Detectable Warning Surface	Curb ramp is located such that it does not project into roadway or parking aisles:	N/A
	Detectable warning is present:	YES
	DWS maintains correct geometric controls; 0.9" diameter domes, 0.2" in height, spaced at 2.35" and visually contrasts adjacent ramp surface:	NO
Special Ramps	Ramp maintains defined edges parallel to direction of pedestrian travel; maintains 4'x4' turning pad contained in crosswalk; flared sides 24" segment on each side of ramp within crosswalk lines:	N/A

Ramp is located so they will not be obstructed by parked vehicles:	N/A
	Ramp wholly contained within the crosswalk lines:	YES
	If island is present; Island maintains a cut through at street level or ramps on either side with landing between them:	N/A
