**CITY OF SAN MARCOS  
ADA TRANSITION PLAN  
SIGNALIZED INTERSECTION ASSESSMENT  
AND COMPLIANCE REPORT**

Location ID: 0000000237  
 North-South Cross Street: CRADDOCK AVE  
 East-West Cross Street: RANCH ROAD 12

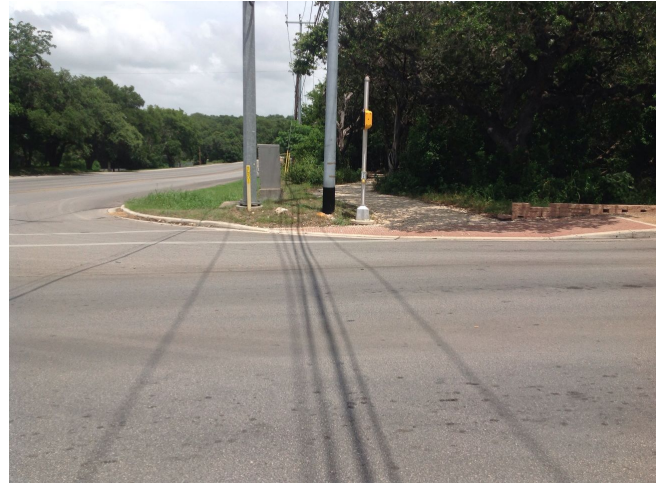
Signalized Intersection: YES  
 Accessible Features: YES  
 Pedestrian Features Accessible: YES

<b>Ramp Elements</b>	Curb ramp provided where an accessible route crosses a barrier:	YES
	Is the slope of the ramp 1:12 or less:	YES
	Transition from curb ramp slope to roadway free from abrupt changes, no greater than 1:20:	NO
	Ramp is at least 36" wide:	YES
	Ramp surface is stable, firm, and slip resistant:	YES
<b>Flare</b>	Flares (if present) are 1:10 or less measured along the curb line; or If landing at top of ramp is not provided flares are 1:12 or less:	NO
<b>Detectable Warning Surface</b>	Curb ramp is located such that it does not project into roadway or parking aisles:	N/A
	Detectable warning is present:	YES
	DWS maintains correct geometric controls; 0.9" diameter domes, 0.2" in height, spaced at 2.35" and visually contracts adjacent ramp surface:	NO
<b>Special Ramps</b>	Ramp maintains defined edges parallel to direction of pedestrian travel; maintains 4'x4' turning pad contained in crosswalk; flared sides 24" segment on each side of ramp within crosswalk lines:	N/A

Ramp is located so they will not be obstructed by parked vehicles:	N/A
	Ramp wholly contained within the crosswalk lines:	YES
	If island is present; Island maintains a cut through at street level or ramps on either side with landing between them:	N/A
