**CITY OF SAN MARCOS
ADA TRANSITION PLAN
SIGNALIZED INTERSECTION ASSESSMENT
AND COMPLIANCE REPORT**

Location ID: 0000000241
 North-South Cross Street: SESSOM DR
 East-West Cross Street: COMANCHE ST

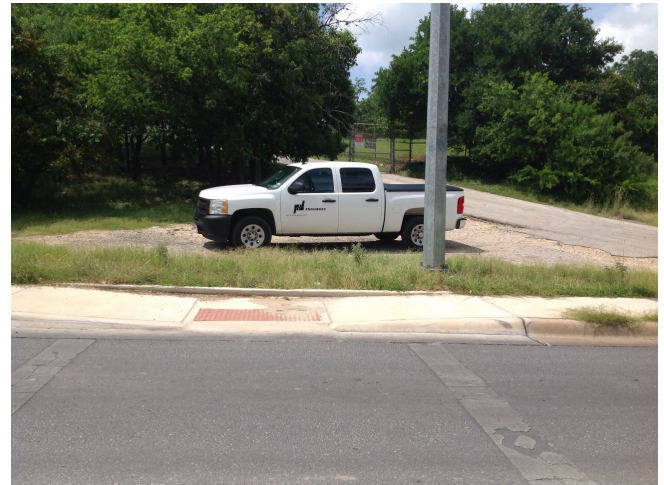
Signalized Intersection: YES
 Accessible Features: NO
 Pedestrian Features Accessible: NO

Ramp Elements	Curb ramp provided where an accessible route crosses a barrier:	YES
	Is the slope of the ramp 1:12 or less:	YES
	Transition from curb ramp slope to roadway free from abrupt changes, no greater than 1:20:	YES
	Ramp is at least 36" wide:	YES
	Ramp surface is stable, firm, and slip resistant:	YES
Flare	Flares (if present) are 1:10 or less measured along the curb line; or If landing at top of ramp is not provided flares are 1:12 or less:	N/A
Detectable Warning Surface	Curb ramp is located such that it does not project into roadway or parking aisles:	N/A
	Detectable warning is present:	YES
	DWS maintains correct geometric controls; 0.9" diameter domes, 0.2" in height, spaced at 2.35" and visually contracts adjacent ramp surface:	YES
Special Ramps	Ramp maintains defined edges parallel to direction of pedestrian travel; maintains 4'x4' turning pad contained in crosswalk; flared sides 24" segment on each side of ramp within crosswalk lines:	N/A

Ramp is located so they will not be obstructed by parked vehicles:	N/A
	Ramp wholly contained within the crosswalk lines:	YES
	If island is present; Island maintains a cut through at street level or ramps on either side with landing between them:	N/A
