**CITY OF SAN MARCOS
ADA TRANSITION PLAN
SIGNALIZED INTERSECTION ASSESSMENT
AND COMPLIANCE REPORT**

Location ID: 000000243
 North-South Cross Street: STUDENT CENTER DR
 East-West Cross Street: COMANCHE ST

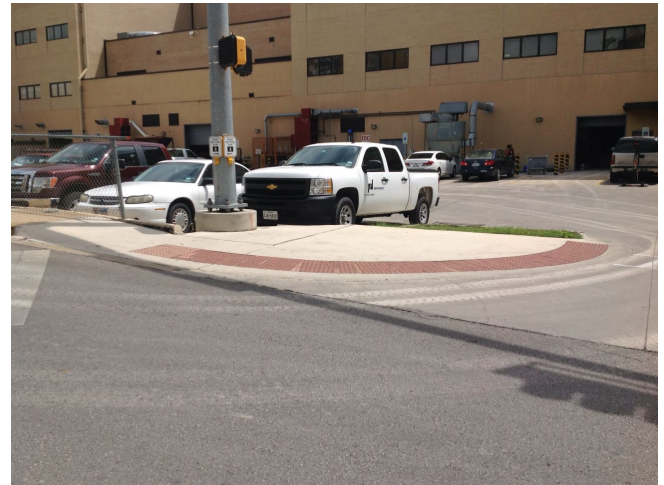
Ramp Elements	Curb ramp provided where an accessible route crosses a barrier:	YES
	Is the slope of the ramp 1:12 or less:	NO
	Transition from curb ramp slope to roadway free from abrupt changes, no greater than 1:20:	NO
	Ramp is at least 36" wide:	YES
	Ramp surface is stable, firm, and slip resistant:	YES
Flare	Flares (if present) are 1:10 or less measured along the curb line; or If landing at top of ramp is not provided flares are 1:12 or less:	N/A
Detectable Warning Surface	Curb ramp is located such that it does not project into roadway or parking aisles:	N/A
	Detectable warning is present:	YES
	DWS maintains correct geometric controls; 0.9" diameter domes, 0.2" in height, spaced at 2.35" and visually contracts adjacent ramp surface:	YES
Special Ramps	Ramp maintains defined edges parallel to direction of pedestrian travel; maintains 4'x4' turning pad contained in crosswalk; flared sides 24" segment on each side of ramp within crosswalk lines:	YES

Ramp is located so they will not be obstructed by parked vehicles:	N/A
	Ramp wholly contained within the crosswalk lines:	NO
	If island is present; Island maintains a cut through at street level or ramps on either side with landing between them:	N/A
