# CITY OF SAN MARCOS ADA TRANSITION PLAN SIGNALIZED INTERSECTION ASSESSMENT AND COMPLIANCE REPORT

Location ID: 0000000244  
 North-South Cross Street: STUDENT CENTER DR  
 East-West Cross Street: COMANCHE ST

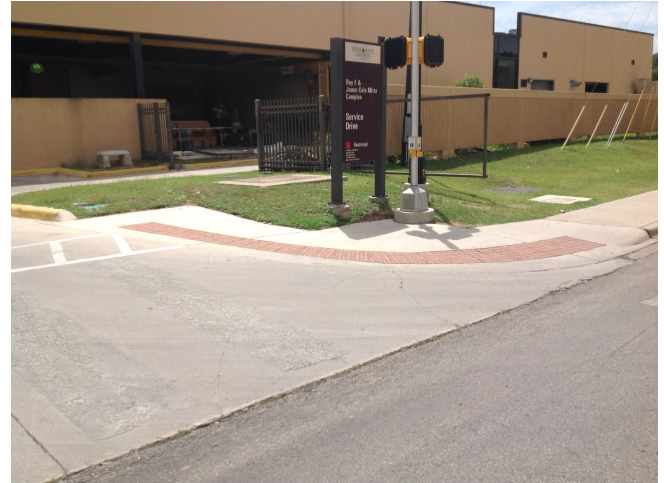
<b>Ramp Elements</b>	Curb ramp provided where an accessible route crosses a barrier:	YES
	Is the slope of the ramp 1:12 or less:	NO
	Transition from curb ramp slope to roadway free from abrupt changes, no greater than 1:20:	NO
	Ramp is at least 36" wide:	YES
	Ramp surface is stable, firm, and slip resistant:	YES
<b>Flare</b>	Flares (if present) are 1:10 or less measured along the curb line; or If landing at top of ramp is not provided flares are 1:12 or less:	NO
<b>Detectable Warning Surface</b>	Curb ramp is located such that it does not project into roadway or parking aisles:	N/A
	Detectable warning is present:	YES
	DWS maintains correct geometric controls; 0.9" diameter domes, 0.2" in height, spaced at 2.35" and visually contracts adjacent ramp surface:	YES
<b>Special Ramps</b>	Ramp maintains defined edges parallel to direction of pedestrian travel; maintains 4'x4' turning pad contained in crosswalk; flared sides 24" segment on each side of ramp within crosswalk lines:	YES

Ramp is located so they will not be obstructed by parked vehicles:	N/A
	Ramp wholly contained within the crosswalk lines:	NO
	If island is present; Island maintains a cut through at street level or ramps on either side with landing between them:	N/A
