# CITY OF SAN MARCOS ADA TRANSITION PLAN SIGNALIZED INTERSECTION ASSESSMENT AND COMPLIANCE REPORT

Location ID: 000000247  
 North-South Cross Street: HOPKINS ST  
 East-West Cross Street: MOORE ST

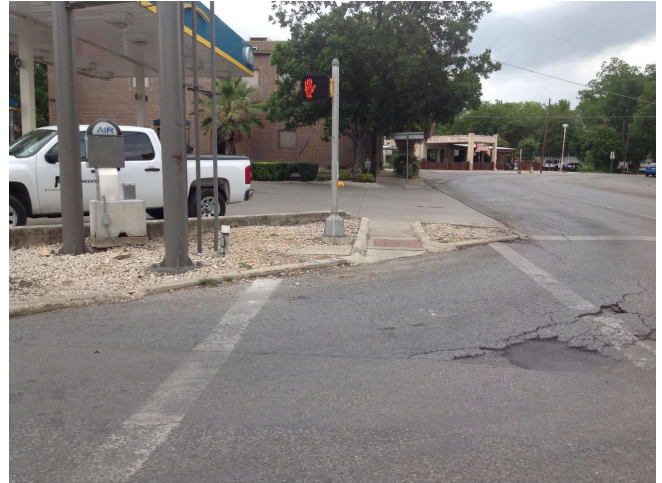
Signalized Intersection: YES  
 Accessible Features: YES  
 Pedestrian Features Accessible: YES

<b>Ramp Elements</b>	Curb ramp provided where an accessible route crosses a barrier:	YES
	Is the slope of the ramp 1:12 or less:	YES
	Transition from curb ramp slope to roadway free from abrupt changes, no greater than 1:20:	NO
	Ramp is at least 36" wide:	YES
	Ramp surface is stable, firm, and slip resistant:	YES
<b>Flare</b>	Flares (if present) are 1:10 or less measured along the curb line; or If landing at top of ramp is not provided flares are 1:12 or less:	N/A
<b>Detectable Warning Surface</b>	Curb ramp is located such that it does not project into roadway or parking aisles:	N/A
	Detectable warning is present:	NO
	DWS maintains correct geometric controls; 0.9" diameter domes, 0.2" in height, spaced at 2.35" and visually contracts adjacent ramp surface:	YES
<b>Special Ramps</b>	Ramp maintains defined edges parallel to direction of pedestrian travel; maintains 4'x4' turning pad contained in crosswalk; flared sides 24" segment on each side of ramp within crosswalk lines:	N/A

Ramp is located so they will not be obstructed by parked vehicles:	N/A
	Ramp wholly contained within the crosswalk lines:	YES
	If island is present; Island maintains a cut through at street level or ramps on either side with landing between them:	N/A
