**CITY OF SAN MARCOS
ADA TRANSITION PLAN
SIGNALIZED INTERSECTION ASSESSMENT
AND COMPLIANCE REPORT**

Location ID: 0000000249
 North-South Cross Street: HUTCHISON ST
 East-West Cross Street: MOORE ST

Location ID: 0000000249

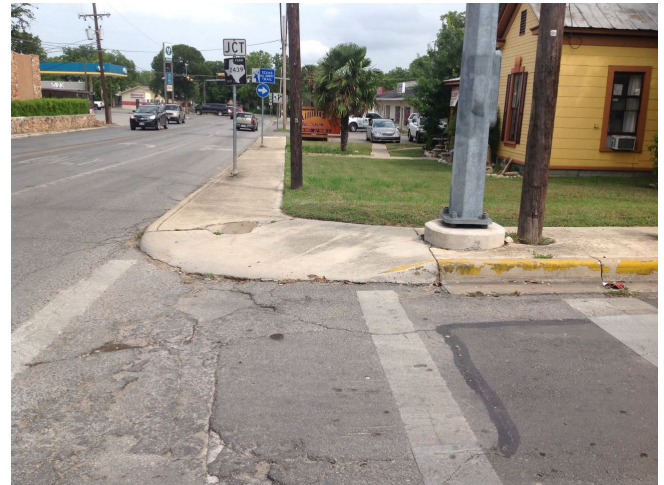
Ramp Elements	Curb ramp provided where an accessible route crosses a barrier:	YES
	Is the slope of the ramp 1:12 or less:	YES
	Transition from curb ramp slope to roadway free from abrupt changes, no greater than 1:20:	NO
	Ramp is at least 36" wide:	YES
	Ramp surface is stable, firm, and slip resistant:	YES
Flare	Flares (if present) are 1:10 or less measured along the curb line; or If landing at top of ramp is not provided flares are 1:12 or less:	YES
Detectable Warning Surface	Curb ramp is located such that it does not project into roadway or parking aisles:	N/A
	Detectable warning is present:	NO
	DWS maintains correct geometric controls; 0.9" diameter domes, 0.2" in height, spaced at 2.35" and visually contrasts adjacent ramp surface:	NO
Special Ramps	Ramp maintains defined edges parallel to direction of pedestrian travel; maintains 4'x4' turning pad contained in crosswalk; flared sides 24" segment on each side of ramp within crosswalk lines:	NO

Ramp is located so they will not be obstructed by parked vehicles:	N/A
	Ramp wholly contained within the crosswalk lines:	YES
	If island is present; Island maintains a cut through at street level or ramps on either side with landing between them:	N/A
