CITY OF SAN MARCOS ADA TRANSITION PLAN SIGNALIZED INTERSECTION ASSESSMENT AND COMPLIANCE REPORT

Location ID: 0000000260
 North-South Cross Street: HOPKINS ST
 East-West Cross Street: EDWARD GARY

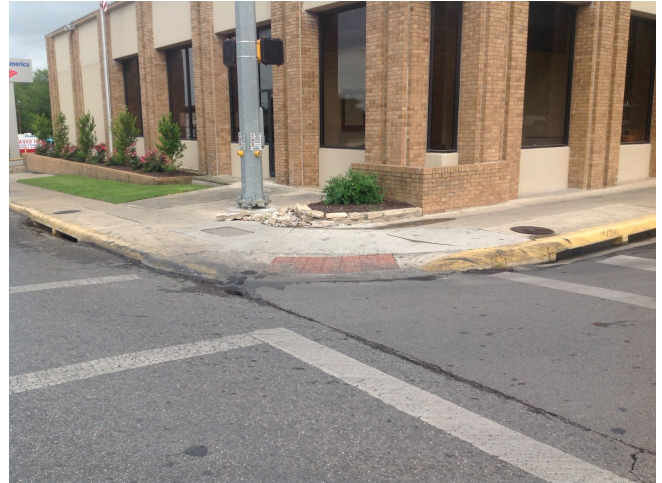
Signalized Intersection: YES
 Accessible Features: YES
 Pedestrian Features Accessible: YES

Ramp Elements	Curb ramp provided where an accessible route crosses a barrier:	YES
	Is the slope of the ramp 1:12 or less:	NO
	Transition from curb ramp slope to roadway free from abrupt changes, no greater than 1:20:	YES
	Ramp is at least 36" wide:	YES
	Ramp surface is stable, firm, and slip resistant:	YES
Flare	Flares (if present) are 1:10 or less measured along the curb line; or If landing at top of ramp is not provided flares are 1:12 or less:	NO
Detectable Warning Surface	Curb ramp is located such that it does not project into roadway or parking aisles:	N/A
	Detectable warning is present:	YES
	DWS maintains correct geometric controls; 0.9" diameter domes, 0.2" in height, spaced at 2.35" and visually contracts adjacent ramp surface:	YES
Special Ramps	Ramp maintains defined edges parallel to direction of pedestrian travel; maintains 4'x4' turning pad contained in crosswalk; flared sides 24" segment on each side of ramp within crosswalk lines:	NO

Ramp is located so they will not be obstructed by parked vehicles:	N/A
	Ramp wholly contained within the crosswalk lines:	YES
	If island is present; Island maintains a cut through at street level or ramps on either side with landing between them:	N/A
