**CITY OF SAN MARCOS
ADA TRANSITION PLAN
SIGNALIZED INTERSECTION ASSESSMENT
AND COMPLIANCE REPORT**

Location ID: 0000000269
 North-South Cross Street: SAN ANTONIO ST
 East-West Cross Street: LBJ ST

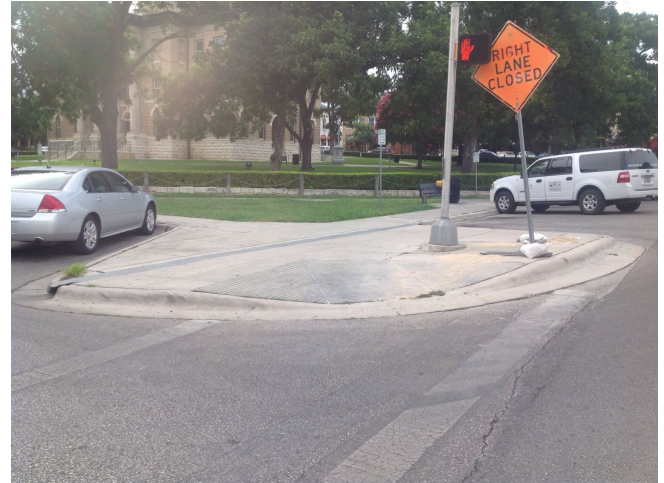
Signalized Intersection: YES
 Accessible Features: YES
 Pedestrian Features Accessible: NO

Ramp Elements	Curb ramp provided where an accessible route crosses a barrier:	YES
	Is the slope of the ramp 1:12 or less:	YES
	Transition from curb ramp slope to roadway free from abrupt changes, no greater than 1:20:	YES
	Ramp is at least 36" wide:	YES
	Ramp surface is stable, firm, and slip resistant:	YES
Flare	Flares (if present) are 1:10 or less measured along the curb line; or If landing at top of ramp is not provided flares are 1:12 or less:	YES
Detectable Warning Surface	Curb ramp is located such that it does not project into roadway or parking aisles:	YES
	Detectable warning is present:	NO
	DWS maintains correct geometric controls; 0.9" diameter domes, 0.2" in height, spaced at 2.35" and visually contracts adjacent ramp surface:	NO
Special Ramps	Ramp maintains defined edges parallel to direction of pedestrian travel; maintains 4'x4' turning pad contained in crosswalk; flared sides 24" segment on each side of ramp within crosswalk lines:	YES

Ramp is located so they will not be obstructed by parked vehicles:	YES
	Ramp wholly contained within the crosswalk lines:	YES
	If island is present; Island maintains a cut through at street level or ramps on either side with landing between them:	N/A
