**CITY OF SAN MARCOS
ADA TRANSITION PLAN
SIGNALIZED INTERSECTION ASSESSMENT
AND COMPLIANCE REPORT**

Location ID: 0000000274
 North-South Cross Street: UNIVERSITY DR
 East-West Cross Street: CM ALLEN PKWY

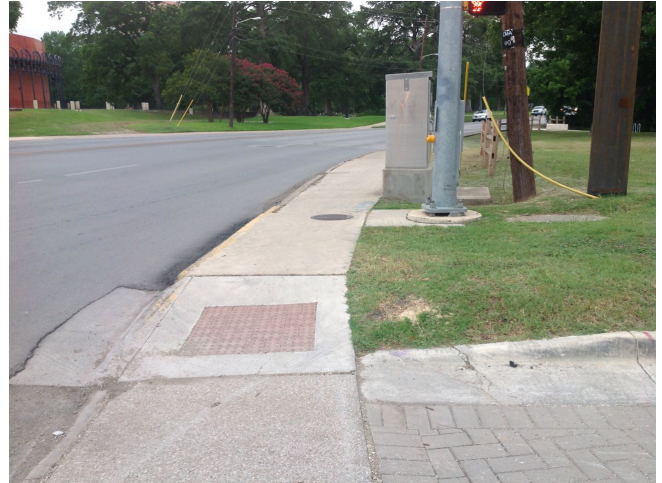
Signalized Intersection: YES
 Accessible Features: YES
 Pedestrian Features Accessible: YES

Ramp Elements	Curb ramp provided where an accessible route crosses a barrier:	YES
	Is the slope of the ramp 1:12 or less:	YES
	Transition from curb ramp slope to roadway free from abrupt changes, no greater than 1:20:	YES
	Ramp is at least 36" wide:	YES
	Ramp surface is stable, firm, and slip resistant:	YES
Flare	Flares (if present) are 1:10 or less measured along the curb line; or If landing at top of ramp is not provided flares are 1:12 or less:	N/A
Detectable Warning Surface	Curb ramp is located such that it does not project into roadway or parking aisles:	N/A
	Detectable warning is present:	NO
	DWS maintains correct geometric controls; 0.9" diameter domes, 0.2" in height, spaced at 2.35" and visually contracts adjacent ramp surface:	YES
Special Ramps	Ramp maintains defined edges parallel to direction of pedestrian travel; maintains 4'x4' turning pad contained in crosswalk; flared sides 24" segment on each side of ramp within crosswalk lines:	N/A

Ramp is located so they will not be obstructed by parked vehicles:	N/A
	Ramp wholly contained within the crosswalk lines:	YES
	If island is present; Island maintains a cut through at street level or ramps on either side with landing between them:	N/A
