CITY OF SAN MARCOS ADA TRANSITION PLAN SIGNALIZED INTERSECTION ASSESSMENT AND COMPLIANCE REPORT

Location ID: 000000278
 North-South Cross Street: SESSOM DR
 East-West Cross Street: PEQUES ST

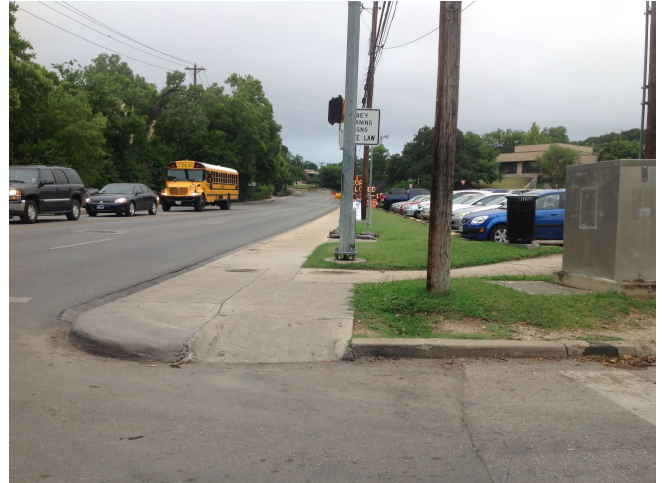
Ramp Elements	Curb ramp provided where an accessible route crosses a barrier:	YES
	Is the slope of the ramp 1:12 or less:	NO
	Transition from curb ramp slope to roadway free from abrupt changes, no greater than 1:20:	YES
	Ramp is at least 36" wide:	YES
	Ramp surface is stable, firm, and slip resistant:	YES
Flare	Flares (if present) are 1:10 or less measured along the curb line; or If landing at top of ramp is not provided flares are 1:12 or less:	NO
Detectable Warning Surface	Curb ramp is located such that it does not project into roadway or parking aisles:	N/A
	Detectable warning is present:	NO
	DWS maintains correct geometric controls; 0.9" diameter domes, 0.2" in height, spaced at 2.35" and visually contracts adjacent ramp surface:	NO
Special Ramps	Ramp maintains defined edges parallel to direction of pedestrian travel; maintains 4'x4' turning pad contained in crosswalk; flared sides 24" segment on each side of ramp within crosswalk lines:	N/A
