CITY OF SAN MARCOS ADA TRANSITION PLAN SIGNALIZED INTERSECTION ASSESSMENT AND COMPLIANCE REPORT

Location ID: 0000000280
 North-South Cross Street: SESSOM DR
 East-West Cross Street: LBJ DR

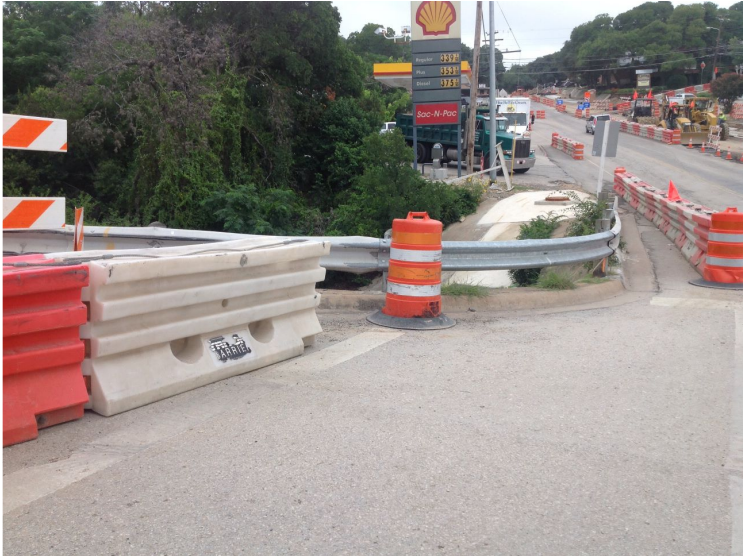
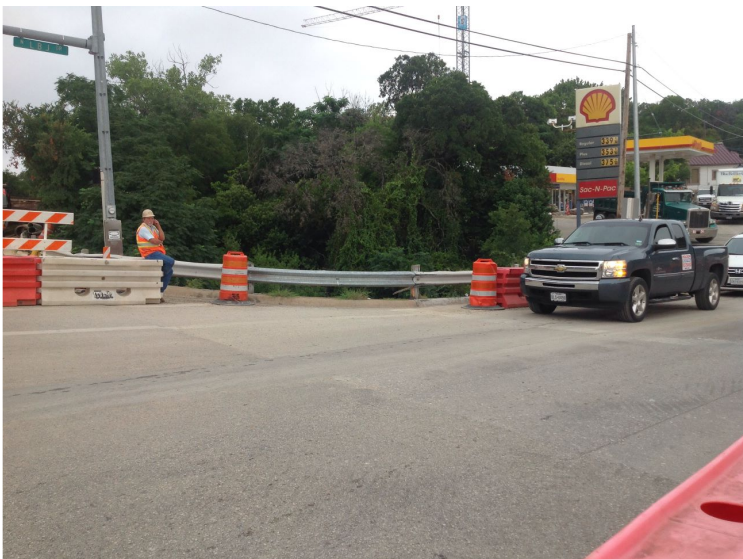
Location Photos

Ramp Elements	Curb ramp provided where an accessible route crosses a barrier:	NO
	Is the slope of the ramp 1:12 or less:	NO
	Transition from curb ramp slope to roadway free from abrupt changes, no greater than 1:20:	NO
	Ramp is at least 36" wide:	NO
	Ramp surface is stable, firm, and slip resistant:	NO
Flare	Flares (if present) are 1:10 or less measured along the curb line; or If landing at top of ramp is not provided flares are 1:12 or less:	NO
Detectable Warning Surface	Curb ramp is located such that it does not project into roadway or parking aisles:	N/A
	Detectable warning is present:	NO
	DWS maintains correct geometric controls; 0.9" diameter domes, 0.2" in height, spaced at 2.35" and visually contracts adjacent ramp surface:	NO
Special Ramps	Ramp maintains defined edges parallel to direction of pedestrian travel; maintains 4'x4' turning pad contained in crosswalk; flared sides 24" segment on each side of ramp within crosswalk lines:	N/A
