**CITY OF SAN MARCOS
ADA TRANSITION PLAN
SIGNALIZED INTERSECTION ASSESSMENT
AND COMPLIANCE REPORT**

Location ID: 0000000283
 North-South Cross Street: HOPKINS ST
 East-West Cross Street: CHARLES AUSTIN DR

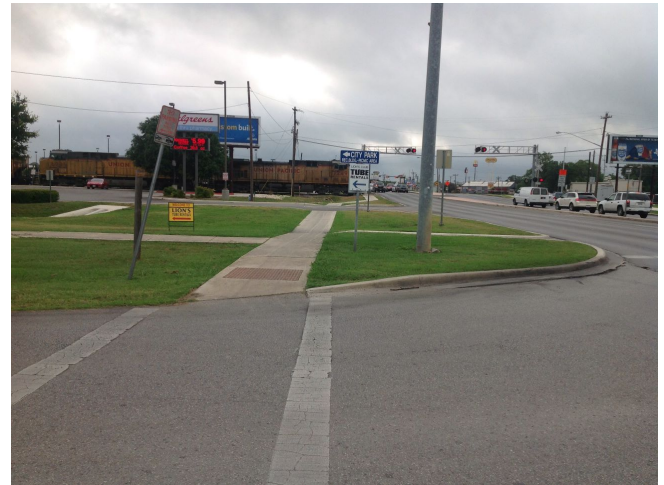
Signalized Intersection: YES
 Accessible Features: NO
 Pedestrian Features Accessible: NO

Ramp Elements	Curb ramp provided where an accessible route crosses a barrier:	YES
	Is the slope of the ramp 1:12 or less:	YES
	Transition from curb ramp slope to roadway free from abrupt changes, no greater than 1:20:	NO
	Ramp is at least 36" wide:	YES
	Ramp surface is stable, firm, and slip resistant:	YES
Flare	Flares (if present) are 1:10 or less measured along the curb line; or If landing at top of ramp is not provided flares are 1:12 or less:	N/A
Detectable Warning Surface	Curb ramp is located such that it does not project into roadway or parking aisles:	N/A
	Detectable warning is present:	YES
	DWS maintains correct geometric controls; 0.9" diameter domes, 0.2" in height, spaced at 2.35" and visually contracts adjacent ramp surface:	YES
Special Ramps	Ramp maintains defined edges parallel to direction of pedestrian travel; maintains 4'x4' turning pad contained in crosswalk; flared sides 24" segment on each side of ramp within crosswalk lines:	N/A

Ramp is located so they will not be obstructed by parked vehicles:	N/A
	Ramp wholly contained within the crosswalk lines:	YES
	If island is present; Island maintains a cut through at street level or ramps on either side with landing between them:	YES
