CITY OF SAN MARCOS ADA TRANSITION PLAN SIGNALIZED INTERSECTION ASSESSMENT AND COMPLIANCE REPORT

Location ID: 0000000285
 North-South Cross Street: HOPKINS ST
 East-West Cross Street: CHARLES AUSTIN DR

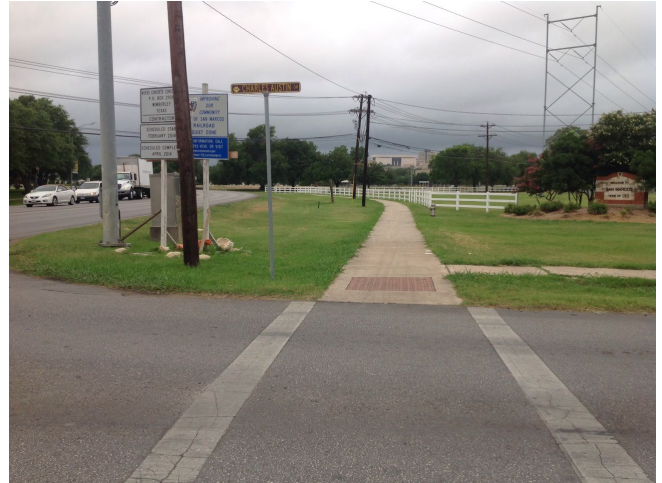
Signalized Intersection: YES
 Accessible Features: NO
 Pedestrian Features Accessible: NO

Ramp Elements	Curb ramp provided where an accessible route crosses a barrier:	NO
	Is the slope of the ramp 1:12 or less:	YES
	Transition from curb ramp slope to roadway free from abrupt changes, no greater than 1:20:	NO
	Ramp is at least 36" wide:	YES
	Ramp surface is stable, firm, and slip resistant:	YES
Flare	Flares (if present) are 1:10 or less measured along the curb line; or If landing at top of ramp is not provided flares are 1:12 or less:	N/A
Detectable Warning Surface	Curb ramp is located such that it does not project into roadway or parking aisles:	N/A
	Detectable warning is present:	NO
	DWS maintains correct geometric controls; 0.9" diameter domes, 0.2" in height, spaced at 2.35" and visually contrasts adjacent ramp surface:	NO
Special Ramps	Ramp maintains defined edges parallel to direction of pedestrian travel; maintains 4'x4' turning pad contained in crosswalk; flared sides 24" segment on each side of ramp within crosswalk lines:	N/A

Ramp is located so they will not be obstructed by parked vehicles:	N/A
	Ramp wholly contained within the crosswalk lines:	YES
	If island is present; Island maintains a cut through at street level or ramps on either side with landing between them:	YES
