**CITY OF SAN MARCOS  
ADA TRANSITION PLAN  
SIGNALIZED INTERSECTION ASSESSMENT  
AND COMPLIANCE REPORT**

Location ID: 0000000290  
 North-South Cross Street: THORPE LN  
 East-West Cross Street: AQUARENA SPRINGS DR

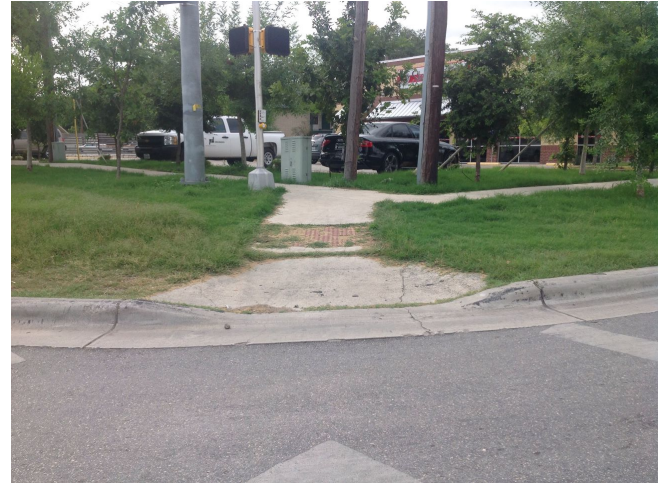
Signalized Intersection: YES  
 Accessible Features: YES  
 Pedestrian Features Accessible: YES

<b>Ramp Elements</b>	Curb ramp provided where an accessible route crosses a barrier:	YES
	Is the slope of the ramp 1:12 or less:	NO
	Transition from curb ramp slope to roadway free from abrupt changes, no greater than 1:20:	NO
	Ramp is at least 36" wide:	YES
	Ramp surface is stable, firm, and slip resistant:	YES
<b>Flare</b>	Flares (if present) are 1:10 or less measured along the curb line; or If landing at top of ramp is not provided flares are 1:12 or less:	YES
<b>Detectable Warning Surface</b>	Curb ramp is located such that it does not project into roadway or parking aisles:	N/A
	Detectable warning is present:	NO
	DWS maintains correct geometric controls; 0.9" diameter domes, 0.2" in height, spaced at 2.35" and visually contracts adjacent ramp surface:	YES
<b>Special Ramps</b>	Ramp maintains defined edges parallel to direction of pedestrian travel; maintains 4'x4' turning pad contained in crosswalk; flared sides 24" segment on each side of ramp within crosswalk lines:	YES

Ramp is located so they will not be obstructed by parked vehicles:	N/A
	Ramp wholly contained within the crosswalk lines:	YES
	If island is present; Island maintains a cut through at street level or ramps on either side with landing between them:	N/A
