**CITY OF SAN MARCOS
ADA TRANSITION PLAN
SIGNALIZED INTERSECTION ASSESSMENT
AND COMPLIANCE REPORT**

Location ID: 0000000296
 North-South Cross Street: POST RD
 East-West Cross Street: UHLAND RD

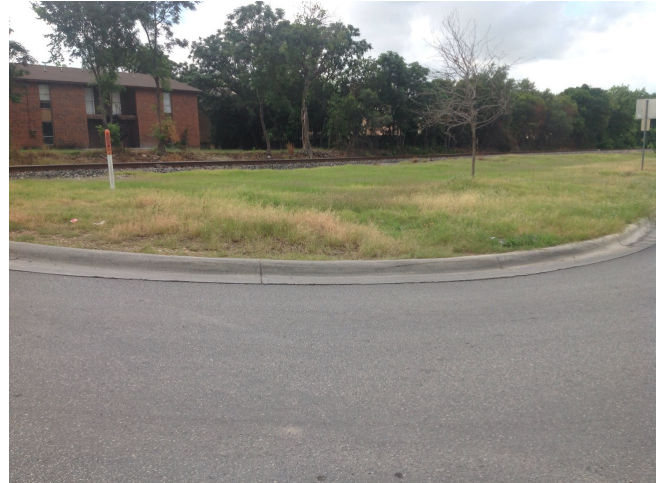
Location Details

Signalized Intersection: YES
 Accessible Features: NO
 Pedestrian Features Accessible: NO

Ramp Elements	Curb ramp provided where an accessible route crosses a barrier:	NO
	Is the slope of the ramp 1:12 or less:	NO
	Transition from curb ramp slope to roadway free from abrupt changes, no greater than 1:20:	NO
	Ramp is at least 36" wide:	NO
	Ramp surface is stable, firm, and slip resistant:	NO
Flare	Flares (if present) are 1:10 or less measured along the curb line; or If landing at top of ramp is not provided flares are 1:12 or less:	NO
Detectable Warning Surface	Curb ramp is located such that it does not project into roadway or parking aisles:	N/A
	Detectable warning is present:	NO
	DWS maintains correct geometric controls; 0.9" diameter domes, 0.2" in height, spaced at 2.35" and visually contracts adjacent ramp surface:	NO
Special Ramps	Ramp maintains defined edges parallel to direction of pedestrian travel; maintains 4'x4' turning pad contained in crosswalk; flared sides 24" segment on each side of ramp within crosswalk lines:	N/A

Ramp is located so they will not be obstructed by parked vehicles:	N/A
	Ramp wholly contained within the crosswalk lines:	N/A
	If island is present; Island maintains a cut through at street level or ramps on either side with landing between them:	N/A
