**CITY OF SAN MARCOS
ADA TRANSITION PLAN
SIGNALIZED INTERSECTION ASSESSMENT
AND COMPLIANCE REPORT**

Location ID: 0000000299
 North-South Cross Street: NBFR IH 35
 East-West Cross Street: AQUARENA SPRINGS DR

Summary of Compliance

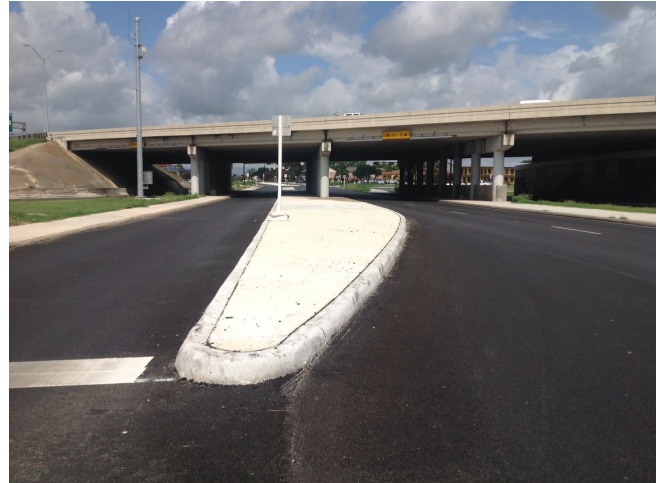
Signalized Intersection: YES
 Accessible Features: NO
 Pedestrian Features Accessible: NO

Ramp Elements	Curb ramp provided where an accessible route crosses a barrier:	NO
	Is the slope of the ramp 1:12 or less:	NO
	Transition from curb ramp slope to roadway free from abrupt changes, no greater than 1:20:	NO
	Ramp is at least 36" wide:	NO
	Ramp surface is stable, firm, and slip resistant:	NO
Flare	Flares (if present) are 1:10 or less measured along the curb line; or If landing at top of ramp is not provided flares are 1:12 or less:	NO
Detectable Warning Surface	Curb ramp is located such that it does not project into roadway or parking aisles:	N/A
	Detectable warning is present:	NO
	DWS maintains correct geometric controls; 0.9" diameter domes, 0.2" in height, spaced at 2.35" and visually contracts adjacent ramp surface:	NO
Special Ramps	Ramp maintains defined edges parallel to direction of pedestrian travel; maintains 4'x4' turning pad contained in crosswalk; flared sides 24" segment on each side of ramp within crosswalk lines:	N/A
