CITY OF SAN MARCOS ADA TRANSITION PLAN SIGNALIZED INTERSECTION ASSESSMENT AND COMPLIANCE REPORT

Location ID: 0000000315
 North-South Cross Street: CLAREWOOD DR
 East-West Cross Street: TX HWY 80

Date of Evaluation: 6/27/2014

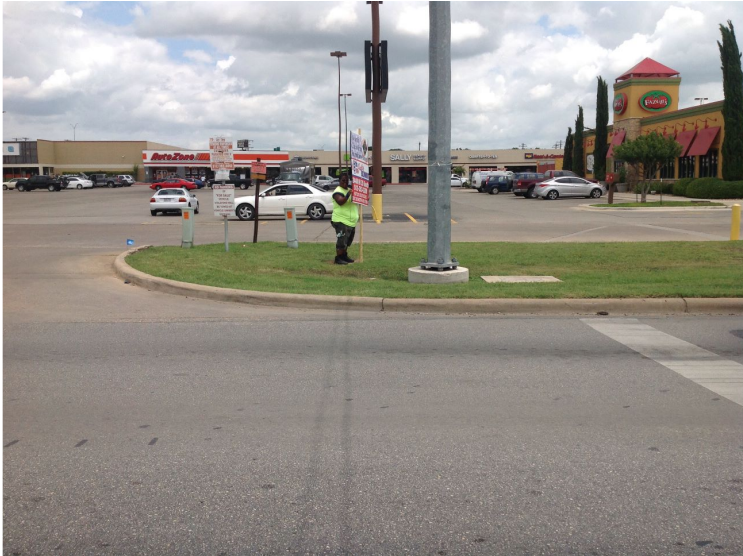
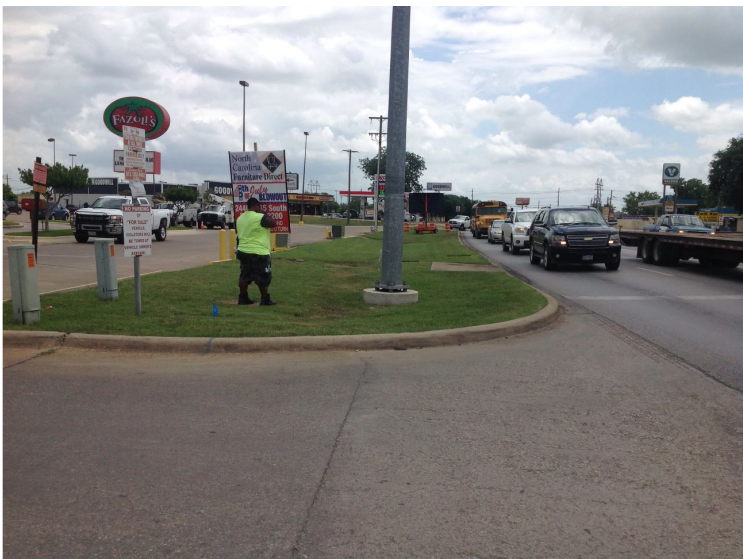
Location Photos

Ramp Elements	Curb ramp provided where an accessible route crosses a barrier:	NO
	Is the slope of the ramp 1:12 or less:	NO
	Transition from curb ramp slope to roadway free from abrupt changes, no greater than 1:20:	NO
	Ramp is at least 36" wide:	NO
	Ramp surface is stable, firm, and slip resistant:	NO
Flare	Flares (if present) are 1:10 or less measured along the curb line; or If landing at top of ramp is not provided flares are 1:12 or less:	NO
Detectable Warning Surface	Curb ramp is located such that it does not project into roadway or parking aisles:	N/A
	Detectable warning is present:	NO
	DWS maintains correct geometric controls; 0.9" diameter domes, 0.2" in height, spaced at 2.35" and visually contracts adjacent ramp surface:	NO
Special Ramps	Ramp maintains defined edges parallel to direction of pedestrian travel; maintains 4'x4' turning pad contained in crosswalk; flared sides 24" segment on each side of ramp within crosswalk lines:	N/A

Ramp is located so they will not be obstructed by parked vehicles:	N/A
	Ramp wholly contained within the crosswalk lines:	N/A
	If island is present; Island maintains a cut through at street level or ramps on either side with landing between them:	N/A
