**CITY OF SAN MARCOS  
ADA TRANSITION PLAN  
SIGNALIZED INTERSECTION ASSESSMENT  
AND COMPLIANCE REPORT**

Location ID: 0000000317  
 North-South Cross Street: RIVER RD  
 East-West Cross Street: TX HWY 80

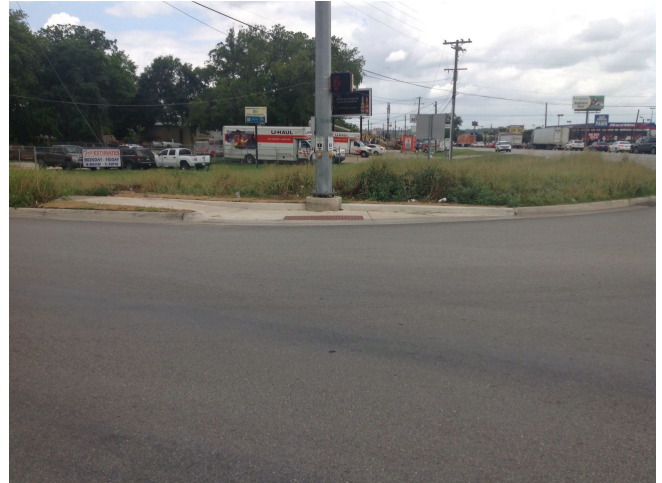
<b>Ramp Elements</b>	Curb ramp provided where an accessible route crosses a barrier:	YES
	Is the slope of the ramp 1:12 or less:	YES
	Transition from curb ramp slope to roadway free from abrupt changes, no greater than 1:20:	YES
	Ramp is at least 36" wide:	YES
	Ramp surface is stable, firm, and slip resistant:	YES
<b>Flare</b>	Flares (if present) are 1:10 or less measured along the curb line; or If landing at top of ramp is not provided flares are 1:12 or less:	YES
<b>Detectable Warning Surface</b>	Curb ramp is located such that it does not project into roadway or parking aisles:	N/A
	Detectable warning is present:	NO
	DWS maintains correct geometric controls; 0.9" diameter domes, 0.2" in height, spaced at 2.35" and visually contracts adjacent ramp surface:	YES
<b>Special Ramps</b>	Ramp maintains defined edges parallel to direction of pedestrian travel; maintains 4'x4' turning pad contained in crosswalk; flared sides 24" segment on each side of ramp within crosswalk lines:	NO

Ramp is located so they will not be obstructed by parked vehicles:	N/A
	Ramp wholly contained within the crosswalk lines:	NO
	If island is present; Island maintains a cut through at street level or ramps on either side with landing between them:	N/A
