CITY OF SAN MARCOS ADA TRANSITION PLAN SIGNALIZED INTERSECTION ASSESSMENT AND COMPLIANCE REPORT

Location ID: 000000066 North-South Cross Street: IH 35 NBFR East-West Cross Street: CENTERPOINT RD Location Details

Date of Evaluation:
 6/25/2014

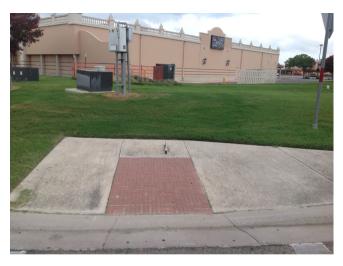
Ramp Elements	Curb ramp provided where an accessible route crosses a barrier: Is the slope of the ramp 1:12 or less:	YES
	Transition from curb ramp slope to roadway free from abrupt changes, no greater than 1:20:	NO
	Ramp is at least 36" wide:	YES
	Ramp surface is stable, firm, and slip resistant:	YES
Flare	Flares (if present) are 1:10 or less measured along the curb line; or If landing at top of ramp is not provided flares are 1:12 or less:	YES
Detectable Warning Surface	Curb ramp is located such that it does not project into roadway or parking aisles:	N/A
	Detectable warning is present:	YES
	DWS maintains correct geometric controls; 0.9" diameter domes, 0.2" in height, spaced at 2.35" and visually contracts adjacent ramp surface:	YES
Special Ramps	Ramp maintains defined edges parallel to direction of pedestrian travel; maintains 4'x4' turning pad contained in crosswalk; flared sides 24" segment on each side of ramp within crosswalk lines:	N/A

Ramp is located so they will not be obstructed by parked vehicles:	N/A
	Ramp wholly contained within the crosswalk lines:	YES
	If island is present; Island maintains a cut through at street level or ramps on either side with landing between them:	N/A
