CITY OF SAN MARCOS ADA TRANSITION PLAN SIGNALIZED INTERSECTION ASSESSMENT AND COMPLIANCE REPORT

Location ID: 0000000233
 North-South Cross Street: HUNTER RD
 East-West Cross Street: STAGECOACH TR

Date of Evaluation: 6/25/2014

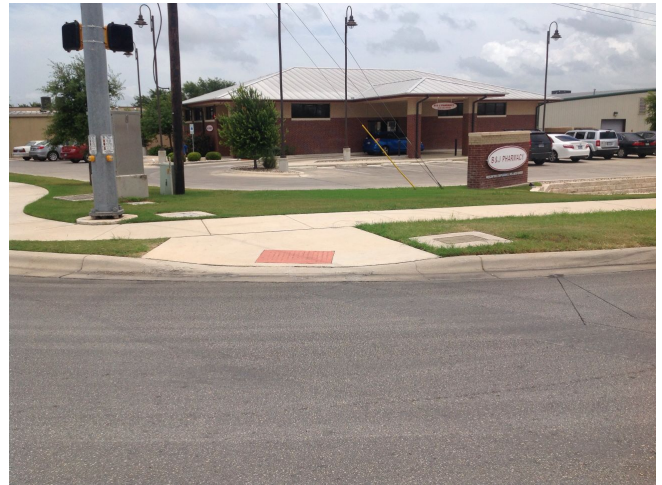
Signalized Intersection: YES
 Accessible Features: YES
 Pedestrian Features Accessible: NO

Ramp Elements	Curb ramp provided where an accessible route crosses a barrier:	YES
	Is the slope of the ramp 1:12 or less:	NO
	Transition from curb ramp slope to roadway free from abrupt changes, no greater than 1:20:	YES
	Ramp is at least 36" wide:	YES
	Ramp surface is stable, firm, and slip resistant:	YES
Flare	Flares (if present) are 1:10 or less measured along the curb line; or If landing at top of ramp is not provided flares are 1:12 or less:	YES
Detectable Warning Surface	Curb ramp is located such that it does not project into roadway or parking aisles:	N/A
	Detectable warning is present:	YES
	DWS maintains correct geometric controls; 0.9" diameter domes, 0.2" in height, spaced at 2.35" and visually contracts adjacent ramp surface:	YES
Special Ramps	Ramp maintains defined edges parallel to direction of pedestrian travel; maintains 4'x4' turning pad contained in crosswalk; flared sides 24" segment on each side of ramp within crosswalk lines:	YES

Ramp is located so they will not be obstructed by parked vehicles:	N/A
	Ramp wholly contained within the crosswalk lines:	N/A
	If island is present; Island maintains a cut through at street level or ramps on either side with landing between them:	N/A
