**CITY OF SAN MARCOS  
ADA TRANSITION PLAN  
SIGNALIZED INTERSECTION ASSESSMENT  
AND COMPLIANCE REPORT**

Location ID: 0000000268  
 North-South Cross Street: SAN ANTONIO ST  
 East-West Cross Street: GUADALUPE ST

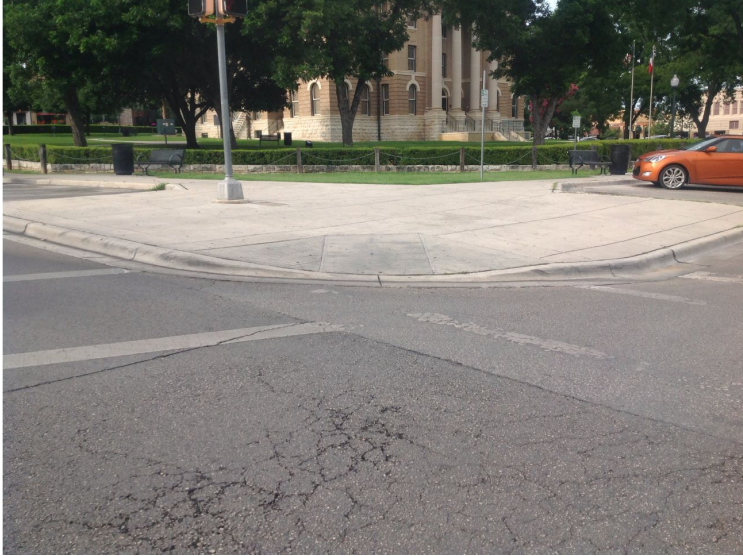
**Location Photos**

<b>Ramp Elements</b>	Curb ramp provided where an accessible route crosses a barrier:	YES
	Is the slope of the ramp 1:12 or less:	NO
	Transition from curb ramp slope to roadway free from abrupt changes, no greater than 1:20:	YES
	Ramp is at least 36" wide:	YES
	Ramp surface is stable, firm, and slip resistant:	YES
<b>Flare</b>	Flares (if present) are 1:10 or less measured along the curb line; or If landing at top of ramp is not provided flares are 1:12 or less:	YES
<b>Detectable Warning Surface</b>	Curb ramp is located such that it does not project into roadway or parking aisles:	YES
	Detectable warning is present:	NO
	DWS maintains correct geometric controls; 0.9" diameter domes, 0.2" in height, spaced at 2.35" and visually contracts adjacent ramp surface:	NO
<b>Special Ramps</b>	Ramp maintains defined edges parallel to direction of pedestrian travel; maintains 4'x4' turning pad contained in crosswalk; flared sides 24" segment on each side of ramp within crosswalk lines:	NO
