CITY OF SAN MARCOS ADA TRANSITION PLAN SIGNALIZED INTERSECTION ASSESSMENT AND COMPLIANCE REPORT

Location ID: 0000000214
 North-South Cross Street: NBFR IH 35
 East-West Cross Street: SH 123

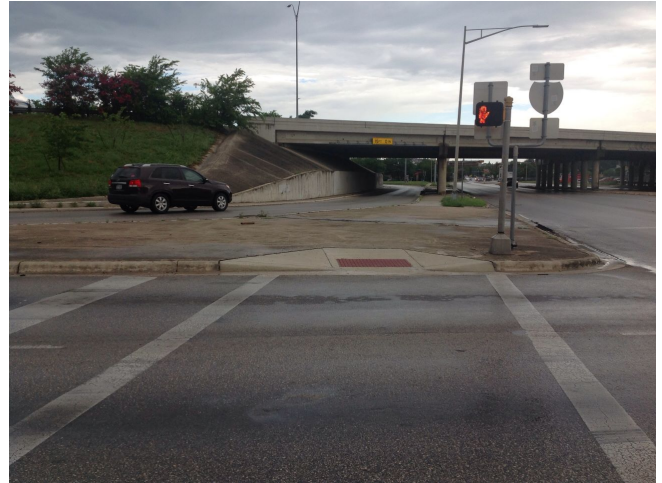
Location Details

Signalized Intersection: YES
 Accessible Features: YES
 Pedestrian Features Accessible: YES
