CITY OF SAN MARCOS ADA TRANSITION PLAN SIGNALIZED INTERSECTION ASSESSMENT AND COMPLIANCE REPORT

Location ID: 000000263 North-South Cross Street: HOPKINS ST East-West Cross Street: LYNDON B JOHNSON DR

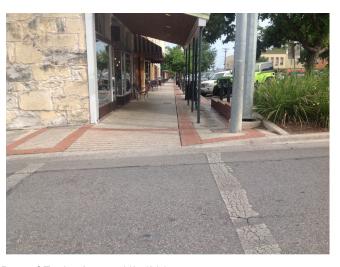
Signalized Intersection: YES Accessible Features: NO Pedestrian Features Accessible: NO

Ramp Elements	Curb ramp provided where an accessible route crosses a barrier:	YES
	Is the slope of the ramp 1:12 or less:	YES
	Transition from curb ramp slope to roadway free from abrupt changes, no greater than 1:20:	NO
	Ramp is at least 36" wide:	YES
	Ramp surface is stable, firm, and slip resistant:	YES
Flare	Flares (if present) are 1:10 or less measured along the curb line; or If landing at top of ramp is not provided flares are 1:12 or less:	YES
Detectable Warning Surface		N/A
	Curb ramp is located such that it does not project into roadway or parking aisles:	1077
	Detectable warning is present:	NO
	DWS maintains correct geometric controls; 0.9" diameter domes, 0.2" in height, spaced at 2.35" and visually contracts adjacent ramp surface:	NO
Special Ramps	Ramp maintains defined edges parallel to direction of pedestrian travel; maintains 4'x4' turning pad contained in crosswalk; flared sides 24" segment on each side of ramp within crosswalk lines:	N/A

Ramp is located so they will not be obstructed by parked vehicles:	N/A
	Ramp wholly contained within the crosswalk lines:	YES
	If island is present; Island maintains a cut through at street level or ramps on either side with landing between them:	N/A
