Utility Conflict Report

OWNER	Utility	CPS	Corridor	SW MILITARY	SITE PHOTOS		
	Contact	JAKE MARTINEZ	ID	3096			
GENERAL INFO	Utility	ELECTRIC

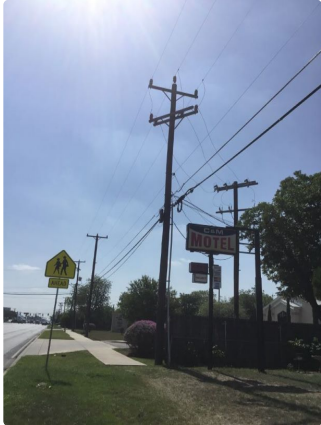
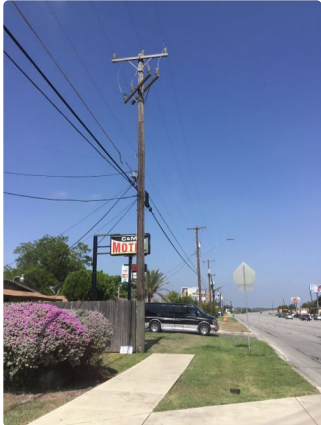
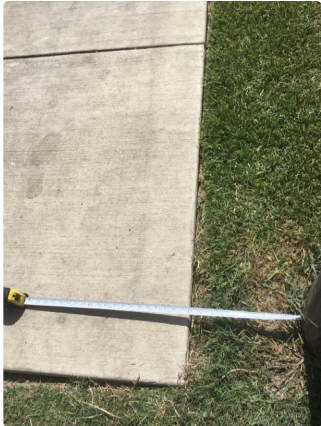
Size and Material	STANDARD POWER POLE, TIMBER					
	Accessible Route	ASSET IS OUTSIDE ACCESSIBLE ROUTE					
	Longitudinal or Crossing	CROSSING					
	Placement Relative to ROW	INSIDE ROW					
LOCATION	Sheet No.	125

Comment	Pole adjacent to back of sidewalk Pole adjacent to fence Pole to base of attached conduit = 1'-10" Sidewalk width = 5'-0" No pole ID					
Date Collected		7/19/2018 10:55:28 AM		Date Modified		11/28/2018 6:59:12 AM

Test Hole No	N/A					
	Test Hole Depth	N/A					
RESOLUTION	Recommended Action	NO CONFLICT					
	Estimated Resolution Date	8/14/2018					
	Resolution Status	NO RESOLUTION WAS REQUIRED
