Utility Conflict Report

| OWNER | Utility | CPS | Corridor | SW MILITARY | SITE PHOTOS | | |
| | Contact | JAKE MARTINEZ | ID | 3110 | | | |

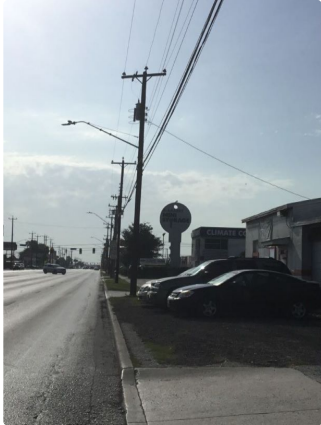
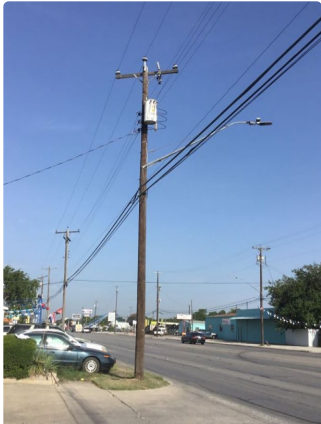
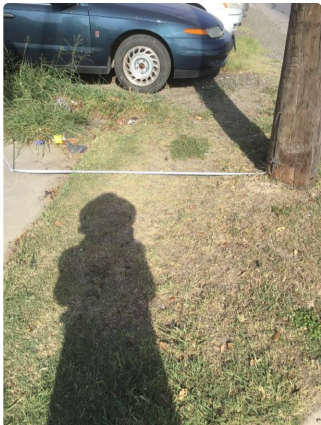
| | Size and Material | STANDARD POWER POLE, TIMBER | | | | | |
| | Accessible Route | ASSET IS INSIDE ACCESSIBLE ROUTE | | | | | |
| | Comment | Pole ID: 464717 Front of sidewalk to pole = 4'-4" Back of curb to front of sidewalk = 8'-6" Back of curb to pole = 3'-0" CATV Cable | | | | | |

| RESOLUTION | Recommended Action | NO CONFLICT | | | | | |
| | Resolution Status | NO RESOLUTION WAS REQUIRED | | | | | |
