## Utility Conflict Report

<b>OWNER</b>	<b>Utility</b>	SAWS	<b>Corridor</b>	SW MILITARY	<b>SITE PHOTOS</b>	
	<b>Contact</b>	ANN PECHE	<b>ID</b>	3117		
<b>GENERAL INFO</b>	<b>Utility</b>	WATER

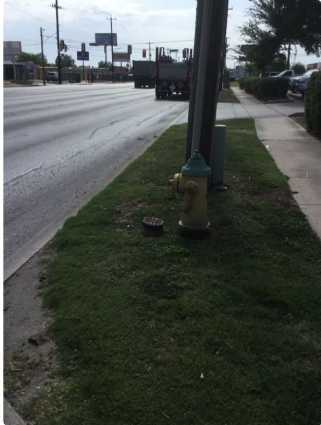
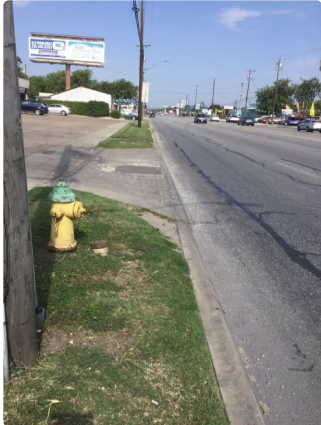
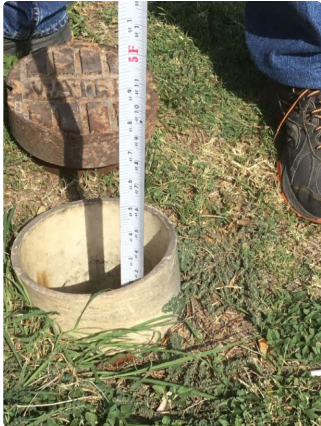
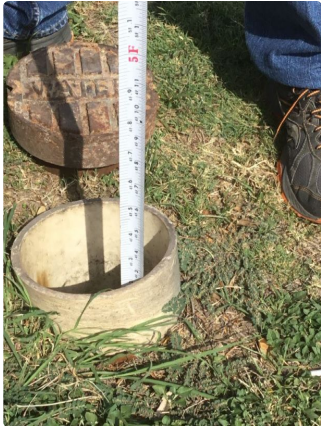
<b>Size and Material</b>	STANDARD WATER VALVE, CAST IRON				
	<b>Accessible Route</b>	ASSET IS OUTSIDE ACCESSIBLE ROUTE				
	<b>Longitudinal or Crossing</b>	CROSSING				
	<b>Placement Relative to ROW</b>	INSIDE ROW				
<b>LOCATION</b>	<b>Sheet No.</b>	134

<b>Estimated Resolution Date</b>					
	<b>Resolution Status</b>	NO RESOLUTION WAS REQUIRED				
	<b>Comment</b>	Front of sidewalk to valve = 4'-5" Top of valve to surface = 4'-2.5" Lid thickness = 2" Sidewalk width = 4'-6" Top of lid = 5" above grade

<b>Test Hole No</b>	N/A				
	<b>Test Hole Depth</b>	N/A				
<b>RESOLUTION</b>	<b>Recommended Action</b>	NO CONFLICT
