Utility Conflict Report

OWNER	Utility	CPS	Corridor	NOGALITOS	SITE PHOTOS		
	Contact	JAKE MARTINEZ	ID	4006			
GENERAL INFO	Utility	ELECTRIC					
	Size and Material	STANDARD POWER POLE, TIMBER					
	Accessible Route	ASSET IS INSIDE ACCESSIBLE ROUTE					
	Longitudinal or Crossing	CROSSING					
	Placement Relative to ROW	INSIDE ROW					
LOCATION	Sheet No.						
	Station	104+20.04					
	Offset	27.8541					
	Latitude	+29.386979					
	Longitude	-98.52329					
SUE	Level of Investigation Req'd	NONE					
	Test Hole No	N/A					
	Test Hole Depth	N/A					
RESOLUTION	Recommended Action	NO CONFLICT					
	Estimated Resolution Date	8/13/2018					
	Resolution Status	NO RESOLUTION WAS REQUIRED

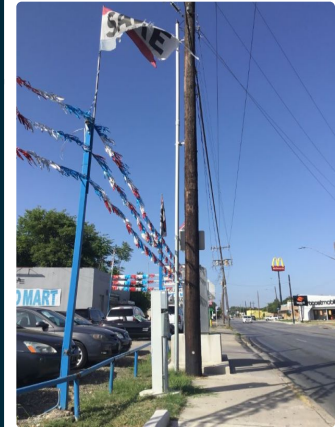
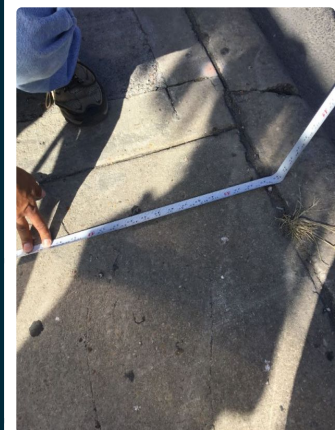
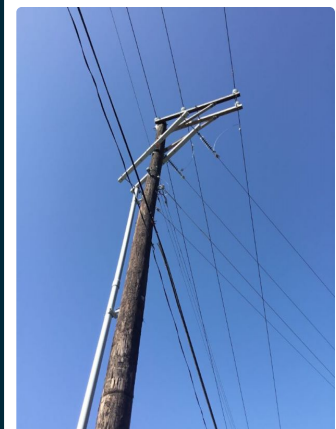
Comment	Pole ID: 449403 Back of curb to traffic signal foundation = 3'-6" Pole to traffic signal foundation = 1'-0" Pole to back of curb = 5'-4" Pole to fence = 3'-0"					
Date Collected		7/2/2018 9:20:54 AM		Date Modified		8/14/2018 4:38:26 PM
