Utility Conflict Report

OWNER	Utility	SAWS	Corridor	SW MILITARY	SITE PHOTOS		
	Contact	ANN PECHE	ID	4109			
GENERAL INFO	Utility	SANITARY SEWER					
	Size and Material	STANDARD MANHOLE, CAST IRON					
	Accessible Route	ASSET IS INSIDE ACCESSIBLE ROUTE					
	Longitudinal or Crossing	CROSSING					
	Placement Relative to ROW	INSIDE ROW					
LOCATION	Sheet No.	130					
	Station	540+78.05					
	Offset	17.08					
	Latitude	+29.357833					
	Longitude	-98.55694					
SUE	Level of Investigation Req'd	NONE					
	Test Hole No	N/A					
	Test Hole Depth	N/A					
RESOLUTION	Recommended Action	MINIMIZE - PROTECT IN PLACE					
	Estimated Resolution Date						
	Resolution Status	UTILITY OWNER INFORMED OF UTILITY

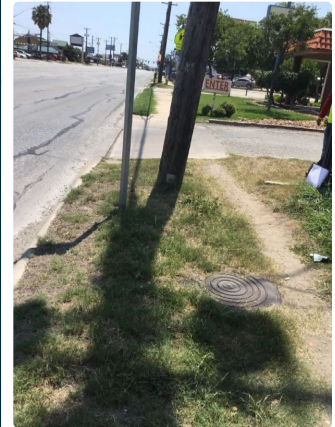
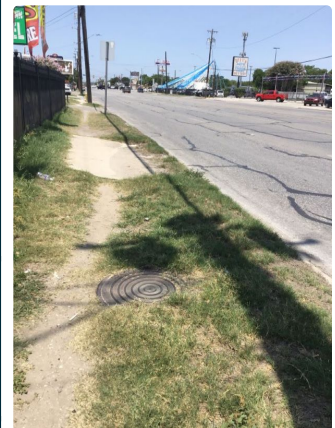
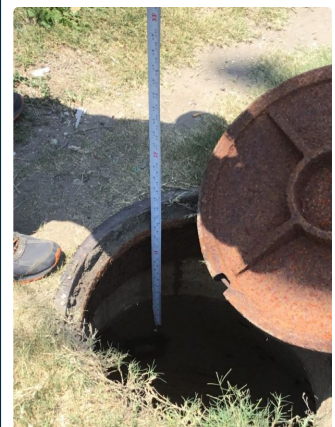
Comment	Back of curb to manhole = 3'-6" Fence to manhole = 3'-9" Back of curb to fence = 9'-6" Bottom of cone to surface = 1'-5" Lid thickness = 1 1/2"					
Date Collected		7/23/2018 12:36:41 PM		Date Modified		11/28/2018 6:59:12 AM
