Utility Conflict Report

| OWNER | Utility | CPS | Corridor | SW MILITARY | SITE PHOTOS |

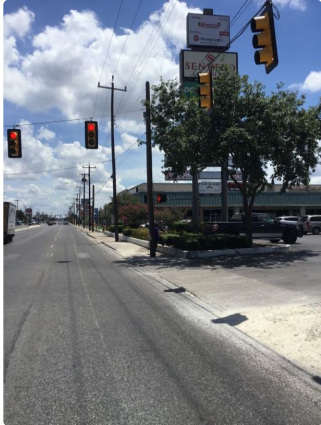
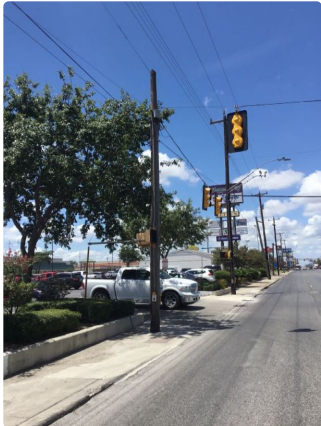
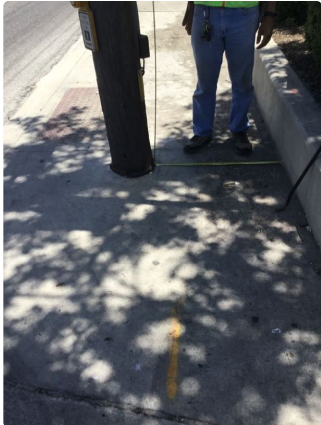
| | Size and Material | STANDARD POWER POLE, TIMBER | | | |
| | Accessible Route | ASSET IS INSIDE ACCESSIBLE ROUTE | | | |
| | Comment | Pole to back of curb = 2'-10" Pole to back of sidewalk = 2'- 10 1/2" Sidewalk width = 6'-9" No pole ID TxDOT Traffic Signal Pole to be relocated | | | |

| RESOLUTION | Recommended Action | NO CONFLICT | | | |
| | Resolution Status | NO RESOLUTION WAS REQUIRED | | | |
